NUMBER 012

VAG 1.9 D / Synchronous Drive / Installation Info.

GATES REFERENCE:	5543XS & Kits, 5559XS & Kits	 
MAKE:	AUDI / SEAT / SKODA / VOLKSWAGEN	
MODEL:	A3, Cordoba, Ibiza, Inca, Leon, Toledo, Octavia, Bora, Caddy, Golf, New Beetle, Polo	
MOTOR:	1.9SDI, 1.9TDI	
MOTOR CODE:	AGP, AGR, AHF, ALH, AQM, ASV, ASY, AYQ

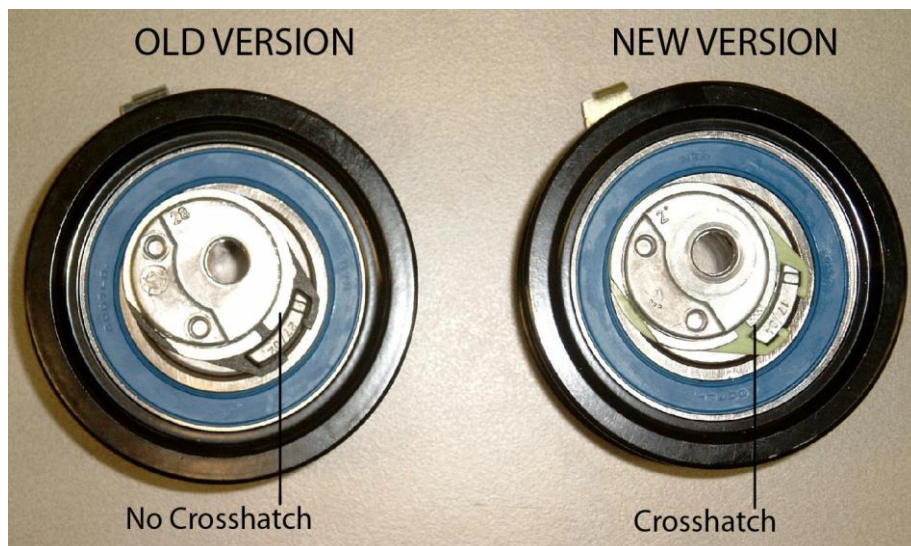
In Fig. 1 you can see that only the new version has a crosshatch belt wear indicator (see also Fig. 4). This section indicates when the timing belt is worn out and when it needs replacement.

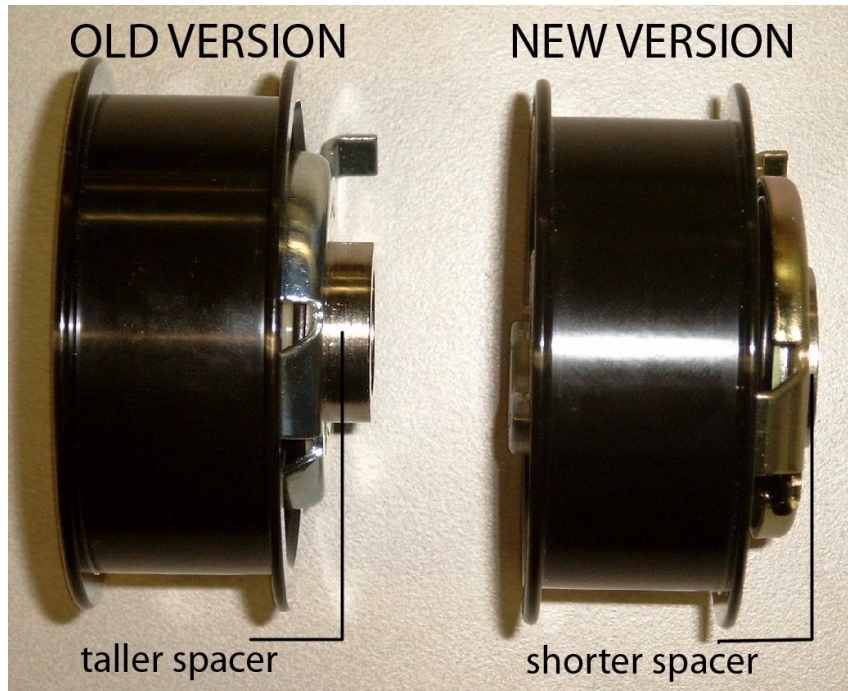
In Fig. 2 you can see that the new tensioner also has a shorter spacer. However, the distance between the engine block and the pulley remains the same.

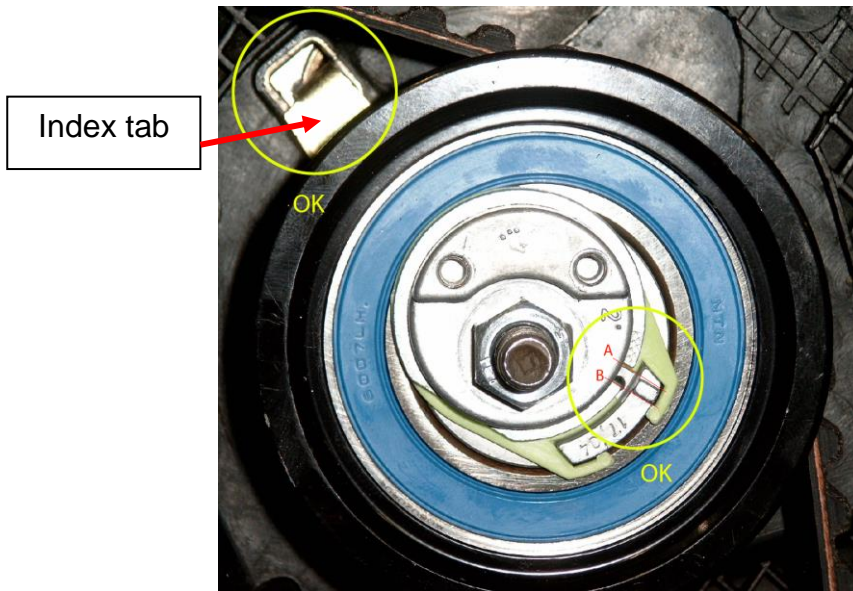
Fig. 3

When after two engine revolutions the pointer is between lines A and B and the index tab is **in** the slot and pushing against the **right hand** side (Fig. 3 and Fig. 4), only then the tensioner is perfectly positioned.

After installation of the new tensioner, verify that the index tab is located and properly seated in the slot (Fig. 3 and Fig. 4). Use the special tool to set the tensioner and turn the tensioner clockwise until the pointer lines up perfectly in the window, between the lines A and B. You can use a mirror to properly see this in the engine compartment. Now tighten the bolt at 23Nm. Now you **must** rotate the engine two revolutions clockwise and then re-check the tensioner pointer. **Do not skip this step!**

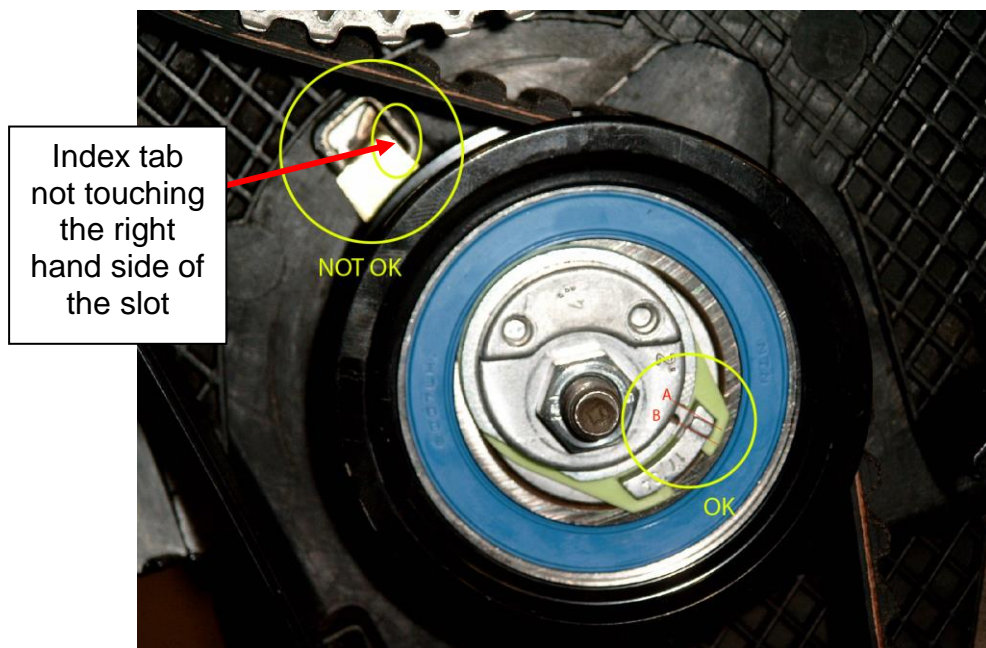
Fig. 5 shows one of the common errors. Pointer is perfectly positioned between lines A and B but the index tab is not OK. The index tab is in the slot but is not pushing against the right hand side of the slot. The reason for this is that the tensioner was moved anti-clockwise during the tensioning process.

If the pointer is not well positioned, the mechanic should restart the tension-setting procedure completely.

When you are in the tension-setting, never turn the tensioner anti-clockwise!

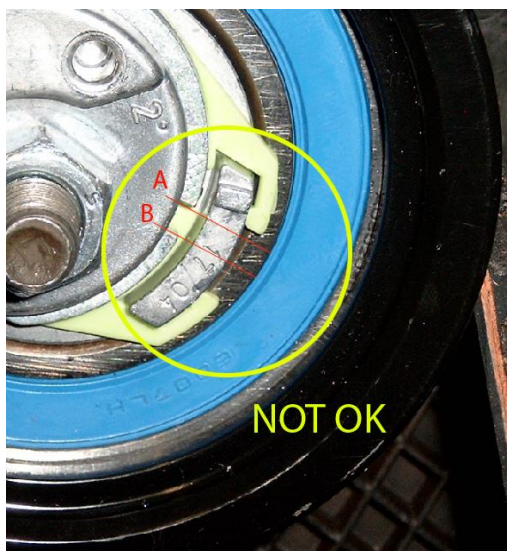
Fig. 6

A second possible error can be seen in Fig. 6. You can see that the pointer has not passed line A and is in front of the crosshatch. This means that the belt will have a too low tension.

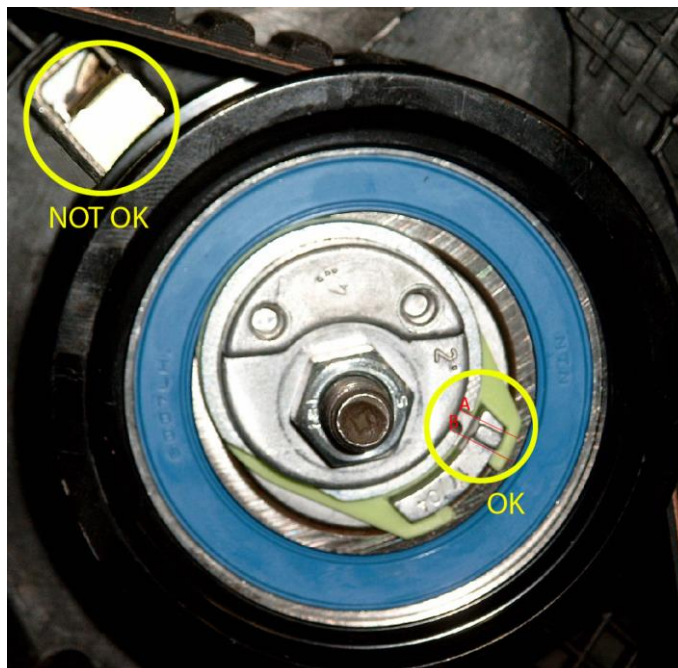
In Fig. 8 you can see a fourth error where the index tab is not locked in the slot although the pointer is perfectly positioned between lines A and B. This way the belt will lose its tension once in operation.

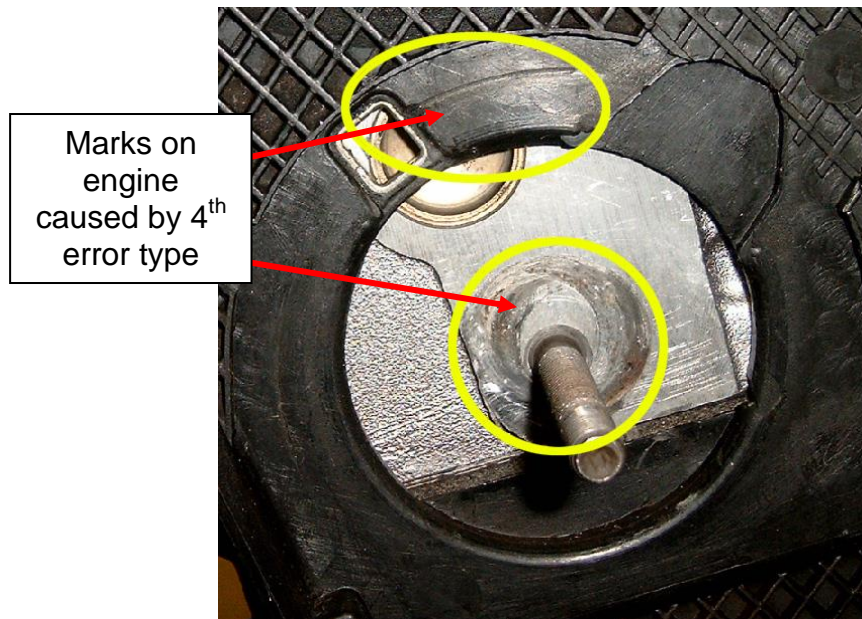
Fig. 9

You can see the marks on the engine caused by this type of wrong fitment in Fig. 9. In this case you will also see that the index tab on the tensioner is slightly bent over.

When the vehicle is released with a wrong positioned tensioner, severe engine damage will happen sooner or later.

We can't stress enough how important it is to follow all the steps in the process of installing this tensioner without skipping one of them. It is better to lose 5 minutes at the installation than to lose an entire engine in the end.
