NUMBER 013

### Renault 1.5 DCI / Accessory drive / Installation Info.

MAKE:	RENAULT	
MODEL:	Clio II, Express, Kangoo, Rapid, Symbol	
MOTOR:	1.5 DCI	
MOTOR CODE:	K9K700, K9K702, K9K710

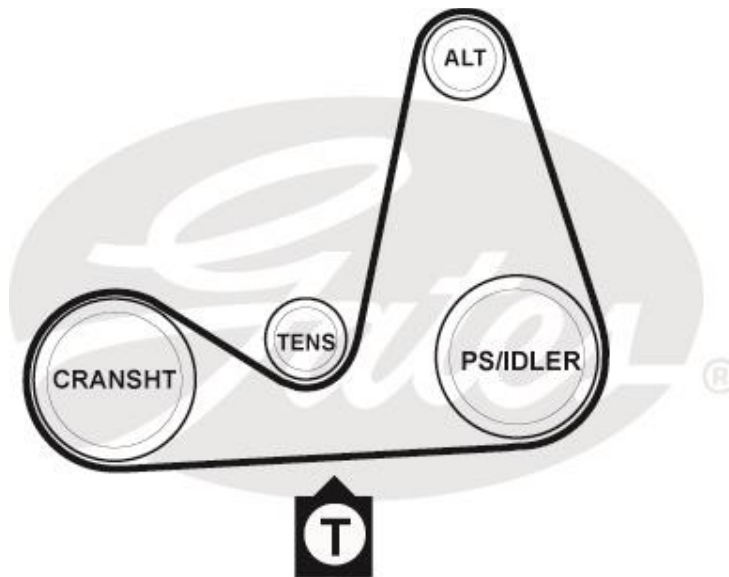
Fig. 1

8. Tension the belt: the belt has to be tensioned (with tool Mot.1638, OE ref. 0000163800) to a higher tension than with the original drive set-up. Measure the tension in the bottom span, between the crankshaft and power steering pump (or idler for cars without power steering) (Fig.1).

9. When measuring the belt tension with the STT-1, key in “8”, “180” (virtual span of 180 mm). When measuring with the Krikitt<sup>®</sup>, tension has to be 70 Kg.
10. Now tighten both bolts (36 Nm).
11. Rotate the engine 2 revolutions clockwise.
12. Check the tension and adjust if needed.
13. Re-install all removed parts.
