GM 1.7D (ISUZU) / Synchronous Drive / Tensioner Info.

GATES REFERENCE:	5563XS & related kits.

MAKE:	CHEVROLET / OPEL / VAUXHALL.	
MODEL:	Astra, Combo, Corsa, Cruze, Meriva, Mokka, Trax, Vita, Zafira.	
MOTOR:	1.7CDTI, 1.7D, 1.7DI, 1.7DTI.	
MOTOR CODE:	A17DT, A17DTC, A17DTE, A17DTF, A17DTJ, A17DTL, A17DTR, A17DTS, Y17DT, Y17DTL, Z17DT, Z17DTH, Z17DTJ, Z17DTR.

This Technical Bulletin replaces Technical Bulletin N° 009.

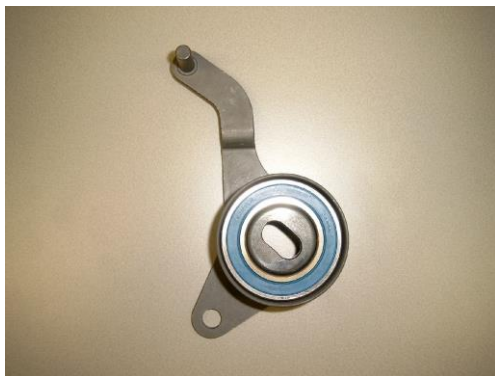
Fig. 1 OE 5636724

Up to engine nr 328703 (last 6 digits) the initial tensioner was installed as shown in Fig. 1. From engine nr 328704 this tensioner was replaced by a new version (Fig. 2). For the 1.7 D engines, OE does not allow to use the old tensioner version anymore.

That is why our kits only contain the new tensioner. (Fig. 2)

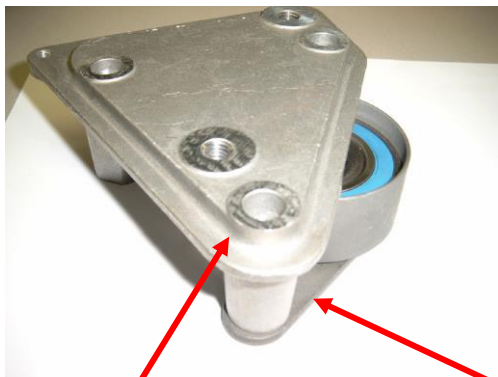
Fig. 3

As the initial tensioner base plate was fitted under a leg of the engine support bracket (Fig. 3), K015563XS can only be used from engine nr 328704 on.

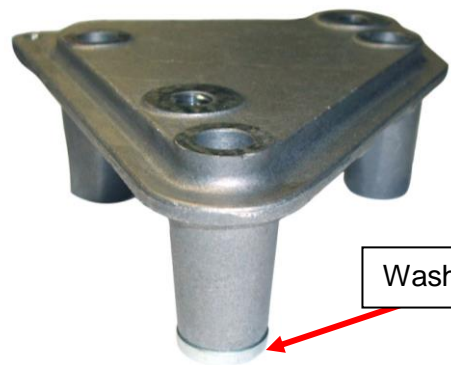
Fig. 4

K025563XS is supplied with a washer to compensate the lost thickness of the base plate under the shorter leg of the early engine support bracket as in Fig. 4, and contains a stud which is needed to hook the new tensioner spring on (Fig. 5). This K02 can always be used: up to engine nr 328703, using the washer and the stud; and from engine nr 328704 without the washer and the stud.

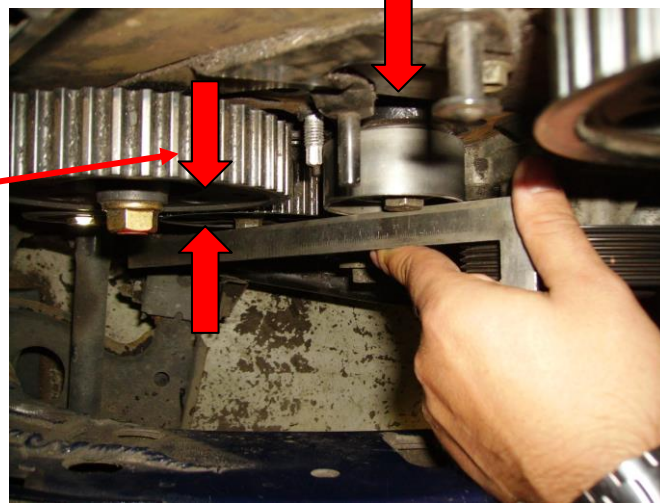
Fig. 6

- 4) Install the new coil spring tensioner (spring over stud, bolt hand tight); make sure tensioner is sitting perfectly against engine block. If not, the spring could end up between the tensioner and the engine block, creating a serious tensioner misalignment (see Fig. 6).
- 5) Rotate the tensioner anticlockwise (Allen key) till the Allen key hole is in +/- 5 o'clock position.
- 6) Tighten the bolt.

Spring trapped behind tensioner

Serious misalignment

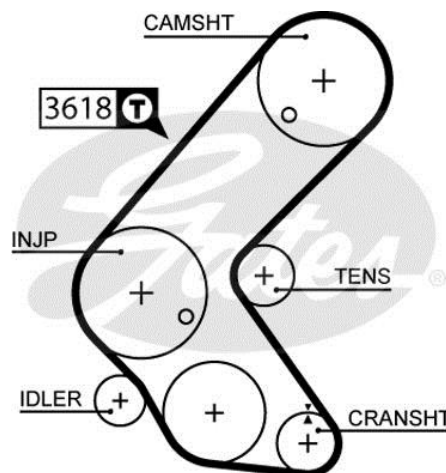
Fig. 7

Failure to observe this procedure could result in the belt tension being too high, leading to an overload on the guide pulley, between the oil pump and injection pump.

** After completing step 10 of the installation in procedure A), or step 9 in procedure B), it is highly recommended to check the tension in span **T**, (see drive system layout below - Fig. 7) using Gates Sonic Tension Tester STT-1.

Enter code 3618 in the STT-1 (ensure chip version 006 is installed) then measure in the normal way. If the tension is too high then the tensioner should be completely released and tensioning procedure repeated until the green light is obtained.

If the tension is too low then it will be necessary to assist the tensioner spring with the Allen key; until the green light is obtained.

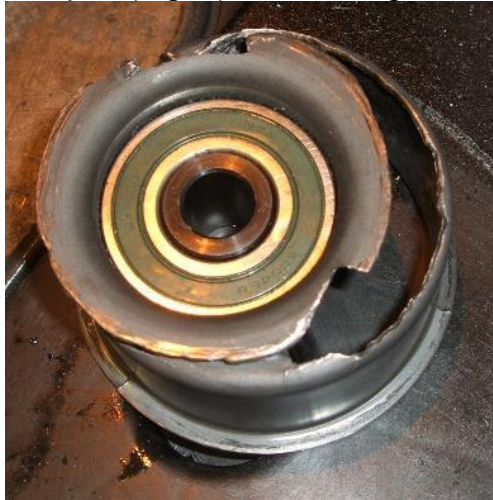
Fig. 8

If the idler is of the old hollow type, this will usually causing the idler pulley to collapse (Fig. 8) and leading to severe engine damage.

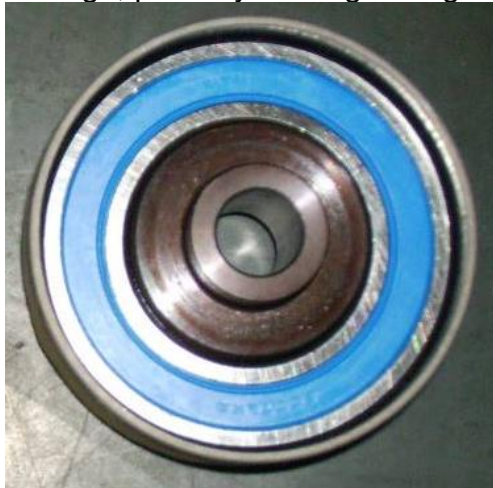
Fig. 9

If the idler is of the new solid type (Fig. 9), the overload will cause belt damage, possibly leading to engine failure.

Our kits contain the new solid idler from code date 201F onwards
