SOFIM 2.4, 2.5, 2.8 Diesel / Synchronous Drive / Installation Info.

GATES REFERENCE:	5039, 5113, 5334XS, 5335XS, 5495XS & related kits.	
MAKE:	FIAT / IVECO / OPEL / PSA / RENAULT.	
MODEL:	Various	
MOTOR:	2.4, 2.5, 2.8 D, TD, DTI, DTIC, DCI, JTD, HDI (all 8 valves)	
MOTOR CODE:	Various

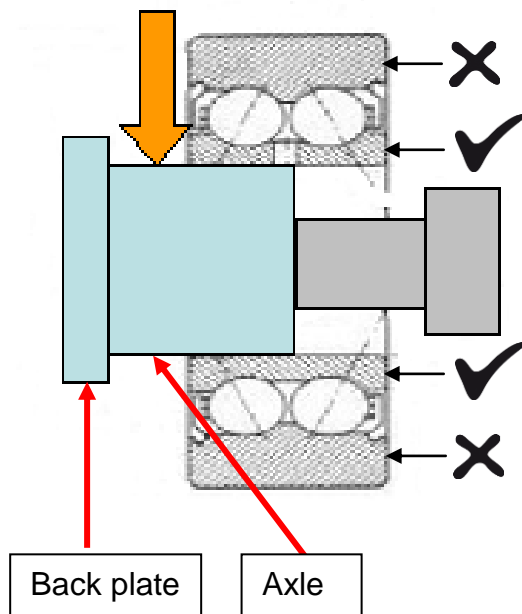
Fig. 1

- Always install the bearing by pushing on the centre part of the bearing (✓)
- Never force the idler over the axle by pushing on the outside of the bearing (✗). (Fig. 1 and Fig. 2)

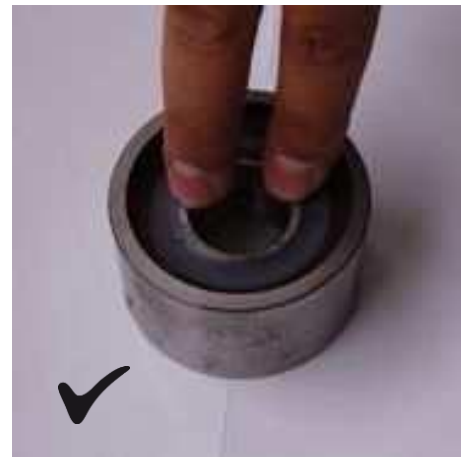
Fig. 2

This would lead to misalignment of the bearing and cause an idler brake-down. It also could lead to the seal coming loose, causing loss of grease and dirt penetration into the bearing.

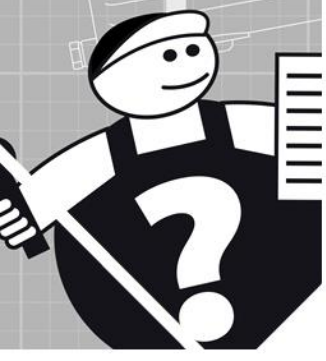
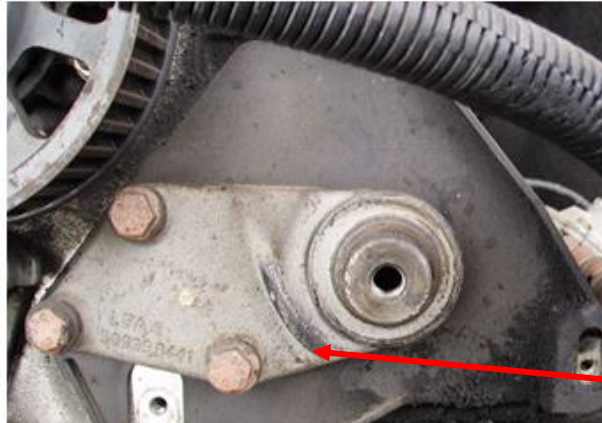
Fig. 3

Misalignment will also lead to the belt coming in contact with the back plate. This will leave a rubbing mark on the back plate (Fig. 3).

Rubbing mark

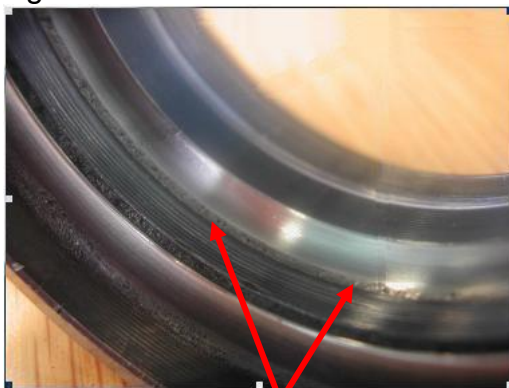
Fig.4

Fig. 4: The bearing balls rolling outside their track due to misalignment and incorrect torque setting.

Ball traces

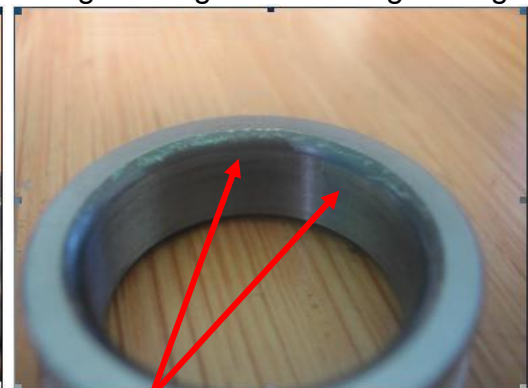
Fig.5

Fig. 5: Abnormal rotation of the interior rings through incorrect tightening.

Abnormal rotation traces

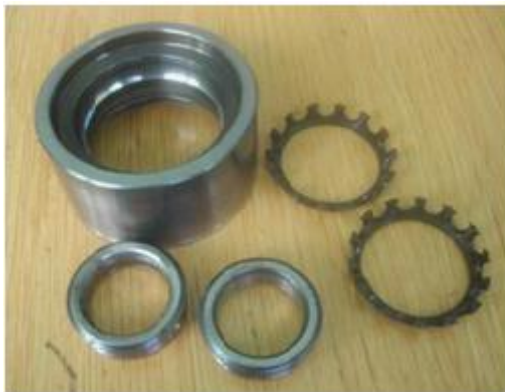
Fig. 6

Fig. 6: A too low tightening torque will lead to the bearing falling apart.
Fig. 7: Deformation of the bearing balls because of excessive temperature, resulting from too high tightening torque.

- Always check the play between the axle and the bearing. If there is excessive play, replace axle/back plate
- Always apply the OE recommended tightening torque; it is very important as it determines the preload of the bearing.
- Always use fixing glue in order to avoid the bolt/nut coming loose due to vibrations and thermal expansion/contraction of the different metal parts (if the bolt/nut loosens, the bearing falls apart) (See Fig. 6).

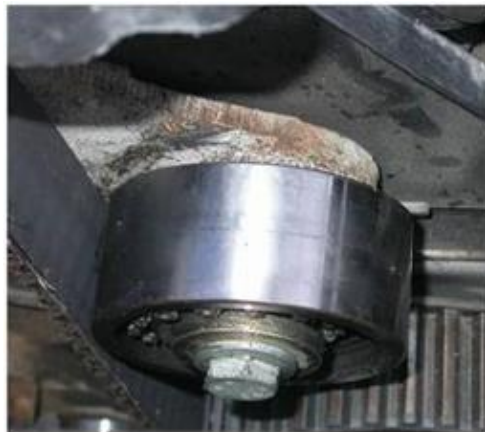
Fig. 8

Figure 8: The seal has come out of the bearing and the ball cage has been completely destroyed.

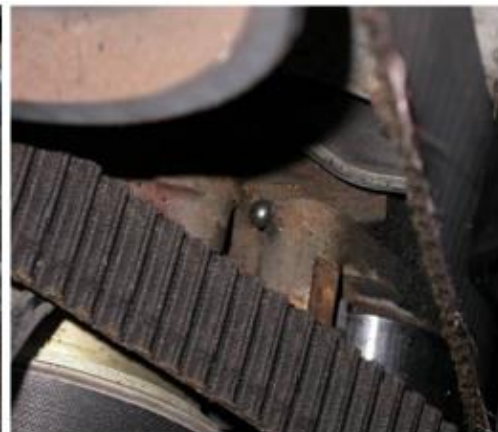
Fig. 9

Figure 9: This results in bearing balls in the lower engine compartment. Remove all possible debris from the drive system.
