FORD 1.8 D / Synchronous Drive / Installation Info.

GATES REFERENCE: 5541XS & related kits.

MAKE: FORD / MAZDA.

MODEL: 121, C-Max, Courier, Fiesta, Focus, Galaxy,

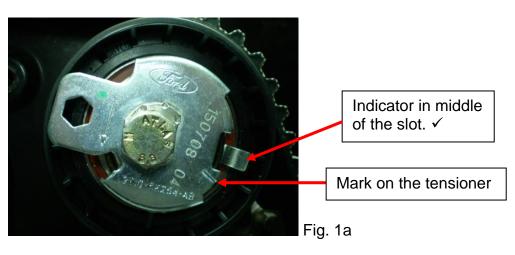
- 1) The engine must be cold: the engine temperature significantly influences the installation parameters.
- 2) The engine must be at TDC. All engine specific setting & locking tools can be found in Gates tool kit GAT4830.
- 3) The crankshaft has to be locked (when equipped with air conditioning, the alternator shaft has to be removed, 6 bolts to loosen).
- 4) The camshaft has to be blocked (at the back of the engine).
- 5) The camshaft sprocket bolt has to be loosened. Make sure the sprocket is free to rotate on the taper, by using the sprocket remover in tool kit GAT4830 (if not done so, the belt will not be tensioned in the top span).
- 6) Turn the tensioner anticlockwise, until the indicator is in **the middle of the slot** (**not** lined up with the mark on the tensioner). (Fig. 1)

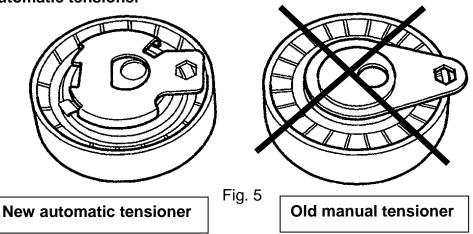
Fig. 5 shows the initial manual tensioner on the right side and the current automatic tensioner on the left.
