NUMBER 031

VAG 1.9, 2.0 TDI / Accessory drive / Installation Info.

GATES REFERENCE:**T38306 & related kits.**

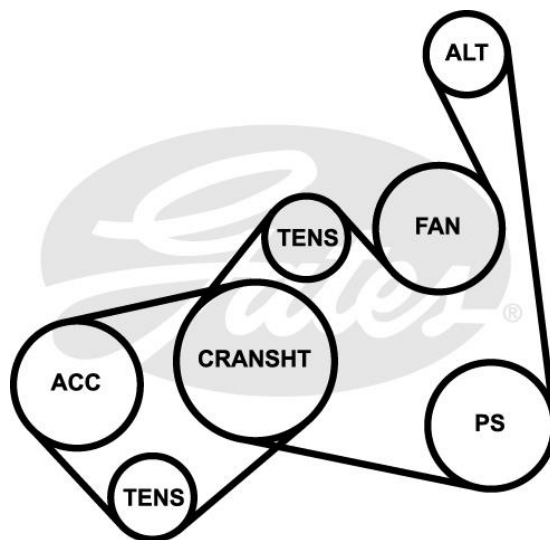
Fig. 1

The layout of the drive is shown as the alternator drive in Fig. 1. As this is a demanding drive, the alternator pulley is of the overrunning (free wheeling) type and the crankshaft is equipped with a Torsional Vibration Damper (TVD).

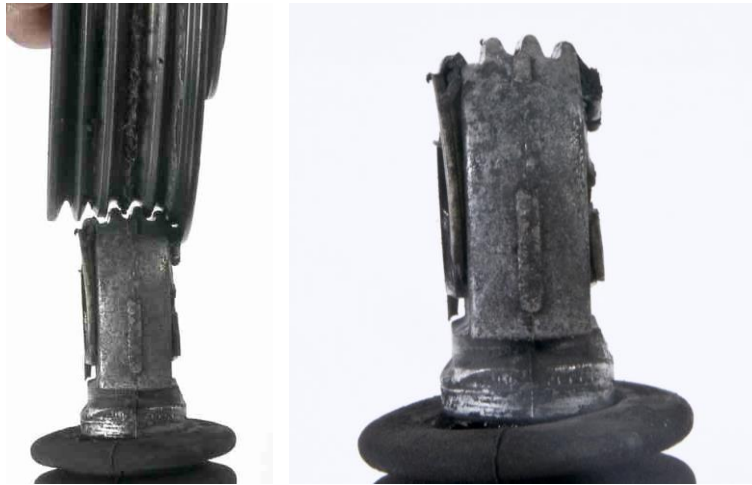
Fig. 3

This play can become enormous, leading to the tensioner body touching the tensioner pulley, causing a lot of noise. In its extreme form the tensioner body will even get grooved, because the pulley is "grinding" it. (Fig. 3)

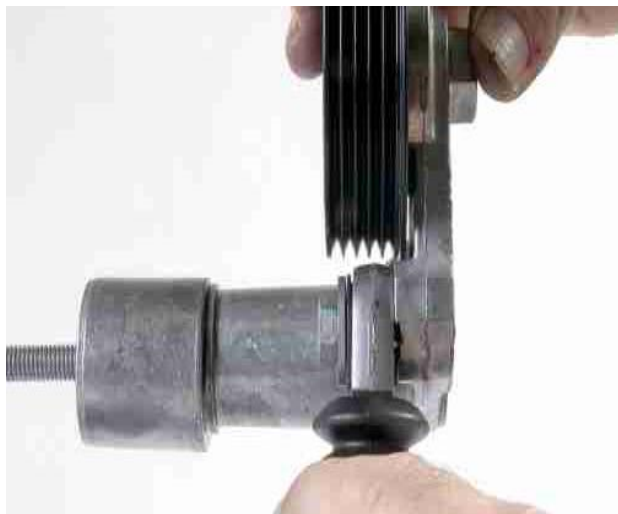
Fig. 4

In new condition, the free space between pulley and tensioner is 5 mm. (Fig. 4)

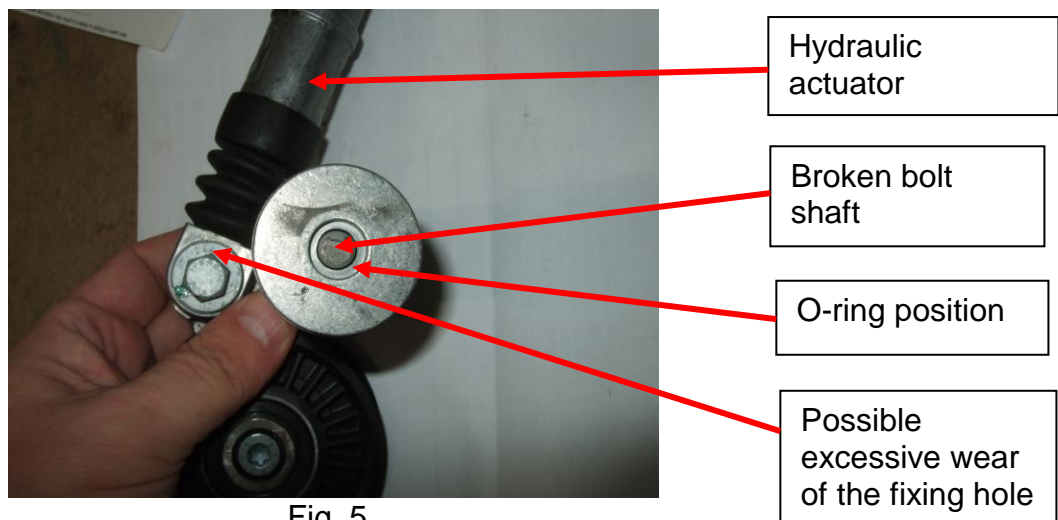
Fig. 5

Also the installation torque of the tensioner mounting bolts is critical. Failure to apply the correct torque will usually lead to the central mounting bolt shearing (Fig. 5).

If the mounting bolts are too tight it will distort the mounting bushing, preventing the hydraulic actuator to pivot on the mounting bolt. All forces are therefore transmitted to the central mounting bolt, which eventually shears.

Bolts on this tensioner should be torqued to 25Nm. In order not to influence the torque of the central bolt, make sure that the o-ring is sitting correctly in its foreseen location. (Fig. 6)
