**VAG 1.4 & 1.6 16V / Synchronous Drive / Installation Info.**

<b>GATES REFERENCE:</b>	<b>5565XS &amp; related kits.</b>	
<b>MAKE:</b>	AUDI, SEAT, SKODA, VOLKSWAGEN.	
<b>MODEL:</b>	Various.	
<b>MOTOR CODE:</b>	1.4 16V, 1.6 16V.

Technical Bulletin

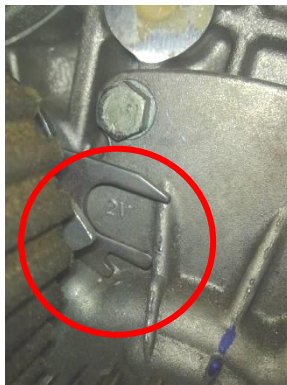
Fig. 2

Any incorrect position of the locating lug (Fig. 2, 3 and 4) will lead to an incorrect belt tension or to the fact the belt cannot be tensioned correctly.

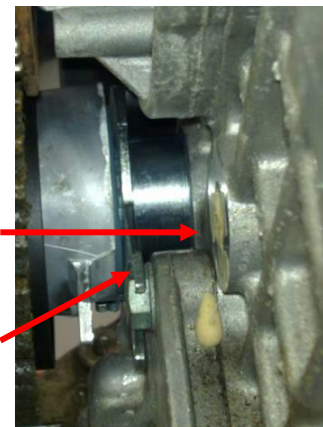
Fig. 10

No gap

Good position

Make sure the thread in the engine block is undamaged and clean.  
 Install the new tensioner.  
 Tighten the tensioner bolt finger tight assuring it's correctly placed (Fig. 10).  
 Install a new PowerGrip® belt.  
 Turn the tensioner pulley clockwise till the pointer and base plate notch are well in line (Fig. 15).

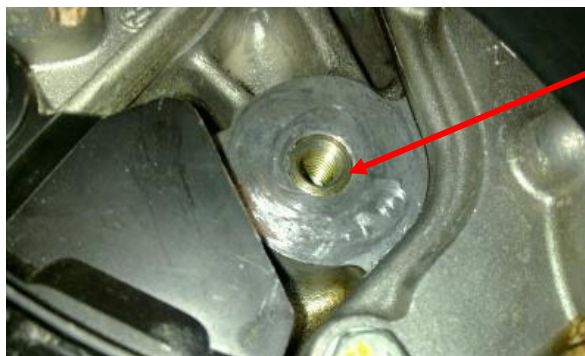
Fig. 11

- deformation of the tensioner leading to overheating of the bearing
- damage of the thread in the alloy engine block, leading to the need of a thread repair (Fig. 11)
- bolt rupture

Repaired thread

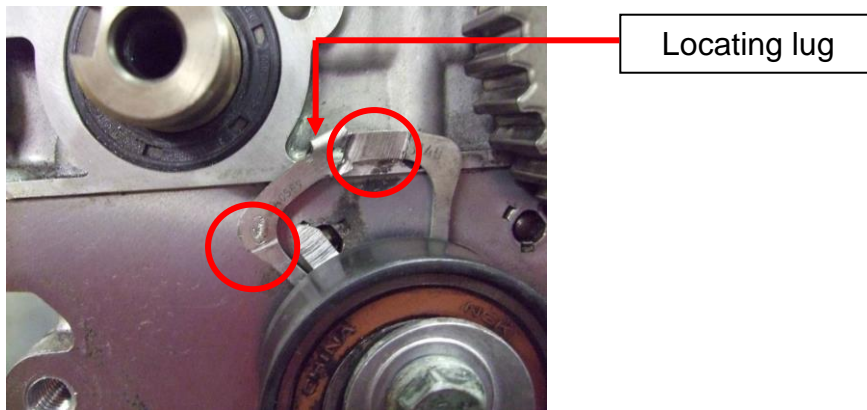
Fig. 18

In one case the tensioner was mounted upside down, with the locating lug trapped behind a part of the cylinder head at 11 o' clock (Fig. 18). When bolting on the tensioner, the back plate deformed, because there was no hole for the lug to fit in.

As a result, the left hand side cam sprocket and the timing belt were touching the back plate, and the belt edge was 'eaten' away until the belt broke. The marks on the tensioner back plate (Fig. 18) and the debris on the inside of the drive cover (Fig. 19) were the clear witnesses of this destruction process.

- the locating lug is placed in the hole in the cylinder head at 6 o'clock (Fig. 17).
- the tensioner is turned anti-clockwise until the pointer is in line with the positioning lug
- the tensioner bolt is torqued to 20 Nm
- the engine is turned 2 revolutions to TDC and pointer position verified (adapt if needed).
