VAG 1.9 D / Accessory Drive / Tensioner info.

GATES REFERENCE:	T38192 & Kits.

MAKE:	AUDI / SEAT / SKODA / VOLKSWAGEN.	
MODEL:	A3, Bora, Caddy, Cordoba, Golf, Ibiza, Inca, Leon, New Beetle, Octavia, Polo, Toledo.	
MOTOR:	1.9 TDI 8V, 1.9 SDI 8V.	
MOTOR CODE:	1Y, 1Z, AEY, AFN, AGR, AHF, AHU, ALE, ALH, ASV, AYQ.

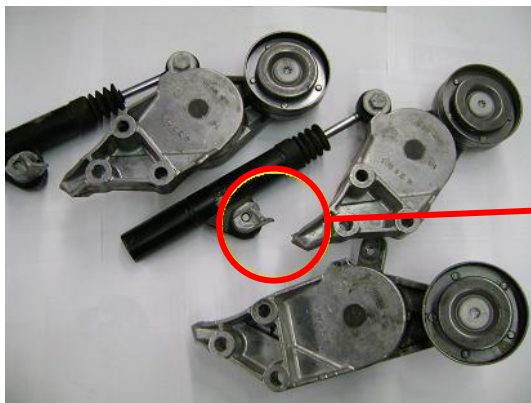
Fig. 1

In most cases where the tensioner seemed to be failing, or even broke down the malfunction of the OAP was proven. The OAP not working properly leads to abnormal belt vibrations, causing the tensioner bracket to be affected by material fatigue; leading to rupture (Fig. 1 and Fig. 2).

The bracket will always shear off at the same point (just above the connection of the bracket with the hydraulic damper).

The broken tensioner bracket is the result of excessive vibrations, not the cause!

- Worn Overrunning Alternator Pulley
- Solid pulley installed instead of an OE prescribed OAP
- Using an OAD (Overrunning Alternator Decoupler) instead of an OWC (One Way Clutch)

- The OAP is a wear item, which has to be checked regularly for proper functioning.
- Replace the alternator pulley only with the prescribed Gates part.
- Follow OE recommended installation procedure.
- Replace all service parts in the drive, use the complete kit.

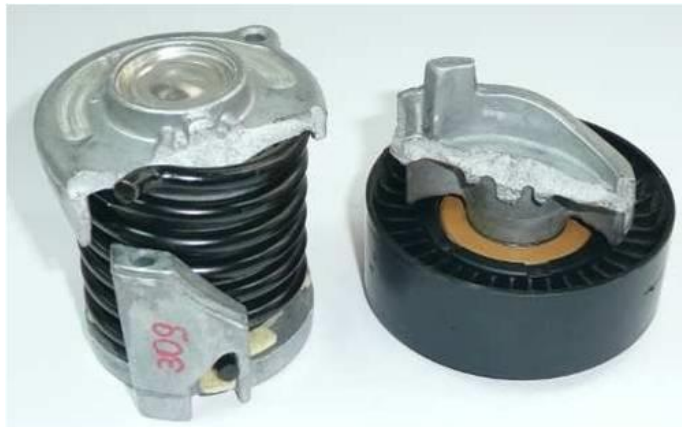
Fig. 3

In all these cases where the OAP did not perform as it should, the hydraulic tensioner element had to cope with abnormal vibrations in the drive; leading to earlier prescribed bracket material fatigue. (Fig. 3)
