febiEXAKT

Suspension arm bush

febi no. 31253

VW Polo (9N), Seat Ibiza (6L), Skoda Fabia (6Y/5J)

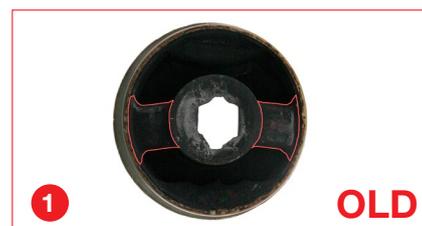
Vehicle manufacturers design suspension arm bushes which are often not strong enough. Their lifetime is also shortened by poor road and weather conditions. The version originally fitted (repl. No. 6Q0 407 183 A) had two rubber bars (Fig. 1) which could tear under unfavourable loads (Fig. 2). This variant has been withdrawn from service at VW and replaced.

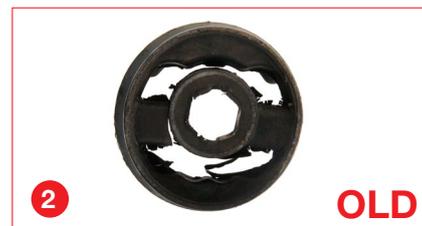
Knocking or creaking noises occur in the axle area when driving.

Faulty suspension arm bush

febi bilstein recommends using the new suspension arm bush febi 31253 (repl. No. 1K0 407 183 E). The strengthened suspension arm bush has four rubber bars and can withstand large loads even under poor road surface and weather conditions (Fig. 3).
