febiEXAKT

Wheel bearing kit including wheel bearing and axle nut

febi no. 24414

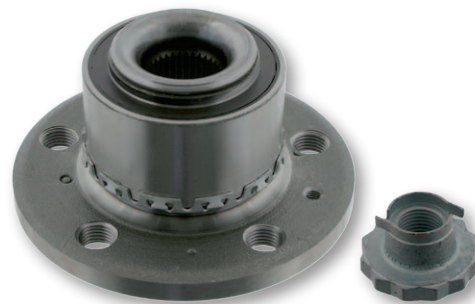
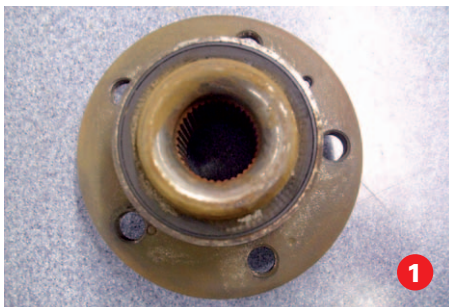
The wheel bearing makes a lot of noise when driving.

Water is getting into the wheel bearing due to a damaged sealing washer and rust is forming, see photos (1) and (2). The sealing washer (3) located between the CV joint and the wheel hub is made of plastic and is easily damaged during removal or due to external factors. When the sealing washer is damaged, it no longer makes proper contact. Water can get inside the wheel bearing more easily once the sealing washer is damaged or dirty. The consequences are premature failure of the bearing and a lot of noise.

Look out for damage to the sealing washer! As a general rule, febi recommends replacing the sealing washer when fitting a wheel bearing. Important: The sealing washer comes in two sizes (64 mm and 72 mm). Pay particular attention to the size (in inches) of the wheels!

Using inappropriate tools for fitting may cause premature failure of the wheel bearing and may also cause a fault indication in the ABS system. Please follow the vehicle manufacturer's repair instructions!
