Water pump

fits Audi A6/avant/quattro, Audi 100/avant
VW LT, VW T4/syncro

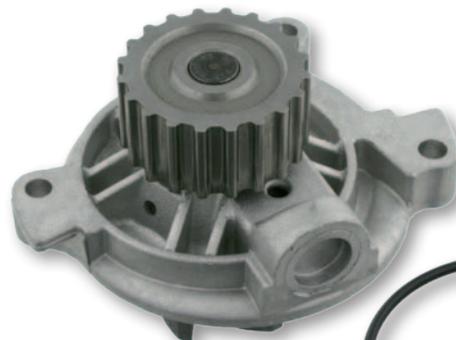
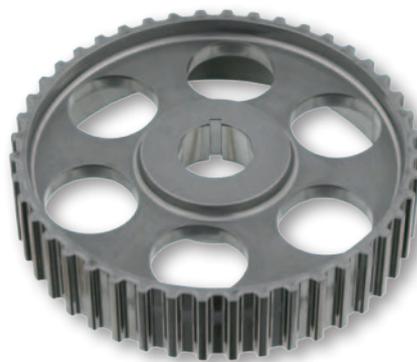
febi no. 22206

Premature failure of the water pump bearing and/or damage in the whole belt drive area, e.g. torn timing belt.

In 5-cylinder engines, the timing belt drives the water pump. The 18-tooth water pumps have a drive wheel that is too small and are overloaded by rotation speeds that are too high. These high loads can lead for example to a faulty water pump bearing. This in turn can lead to the whole pump seizing. It is therefore inevitable that damage will occur in the whole belt drive area, e.g. a tear in the timing belt.

The water pump has been improved. Now with 20 teeth instead of 18 and a larger drive wheel, the rotation speed is lower and wear on the water pump bearing is reduced. The water pump can now withstand the load.

Important: In petrol engines, the camshaft gear also has to be replaced when changing to the new water pump with 20 teeth. The febi 89108 camshaft gear cancels out the „timing shifts“ due to the larger water pump wheel.

It is imperative when changing the timing belt to replace the water pump at the same time!
