Assembly instructions for replacing wheel bearings/hub

Manufacturer:
Volvo

Model: 850, C70, S70, V70 I

Issued 11.2007
FAG 0001

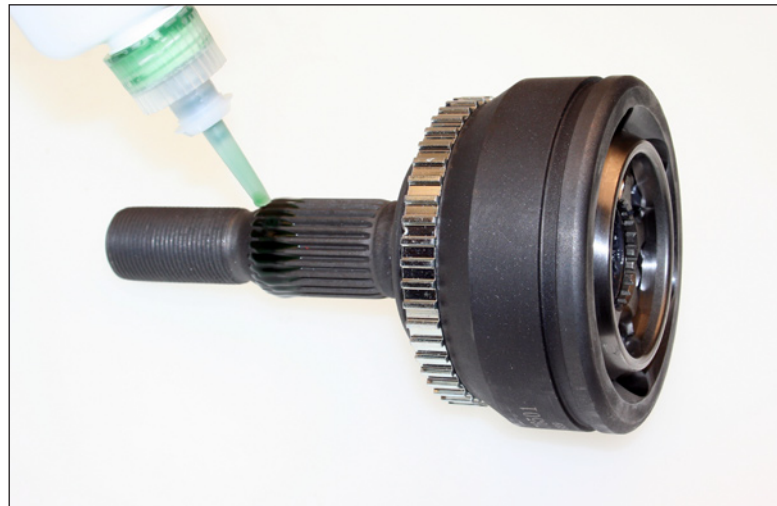
Fig. 1

Vibrations and or knocking noises after fitting the wheel bearing / hub.

The splined drive shaft is loctited into the hub as standard. After re-installation of the splined drive shaft without loctite there may be some play between the hub and the splined drive shaft.

Secure the splined drive shaft with a suitable metal adhesive loctite (e.g. Volvo part number **1161370**) into the hub.

- Clean the spline on the hub and the splined drive shaft.
- Apply a **3-4 mm** bead of the loctite around the outer edge of the straight spline (see **fig. 1**).
