SERVICE-INFO

Maintenance information for Mercedes-Benz accessory unit drives with tensioning arm 533 0017 10

Part no.: 533 0017 10

INA 0082

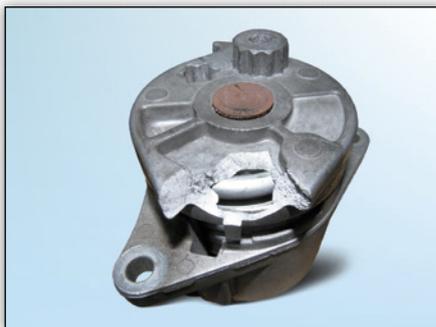
Image 3: Example of a broken 533 0017 10 tensioning arm

In the vehicles listed above, strong dynamic movements in the accessory unit drive may cause tensioning arm 533 0017 10 (**image 3**) to break. This may be caused by a worn or defective over-running alternator pulley.

As a result of this, the entire accessory unit drive will fail, causing the vehicle to break down.

To prevent damage, Schaeffler Automotive Aftermarket therefore recommends that the over-running alternator pulley (**image 4**) be checked and replaced if necessary.

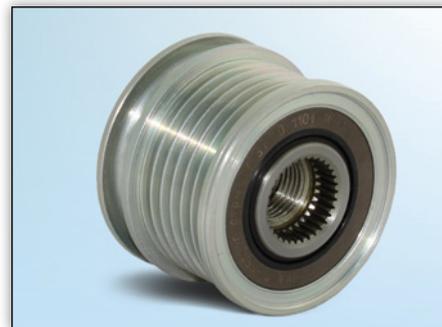
Image 4: Over-running alternator pulley

Use the INA special tool kit (part no. 400 0241 10) to check the over-running alternator pulley.
