Blue Print Bulletin

Ignition Coil ADC41473

Date Issued: 01/06/2005

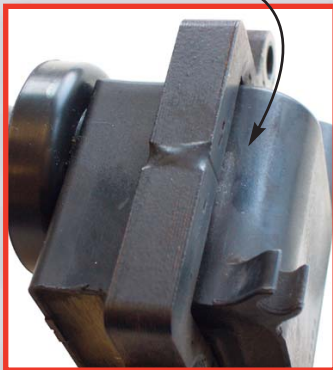
Example A was tracking from the coil body to the laminated core.

Blue Print strongly recommend that the spark plugs and HT leads are replaced in addition to the coil assembly, or that they are carefully checked. We also recommend that a logical diagnosis procedure is followed (prior to replacing the ignition coil) to prevent it being replaced unnecessarily.

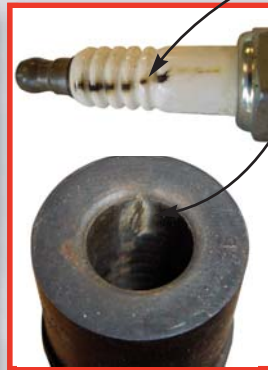
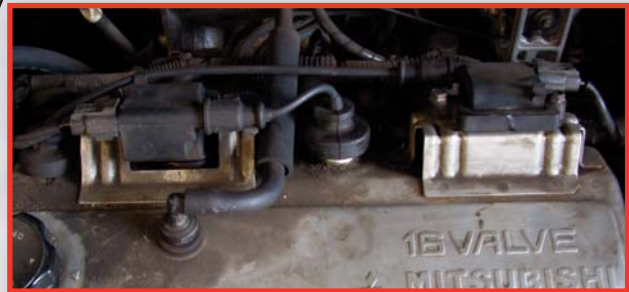
Example B shows where the spark has tracked along the spark plug ceramic (see burn marks).
