# Blue Print Bulletin

## ADC46104C Crank Shaft Pulley

### Subject - Product Information

#### Vehicle – Mitsubishi FTO 2.0 (DE3A)

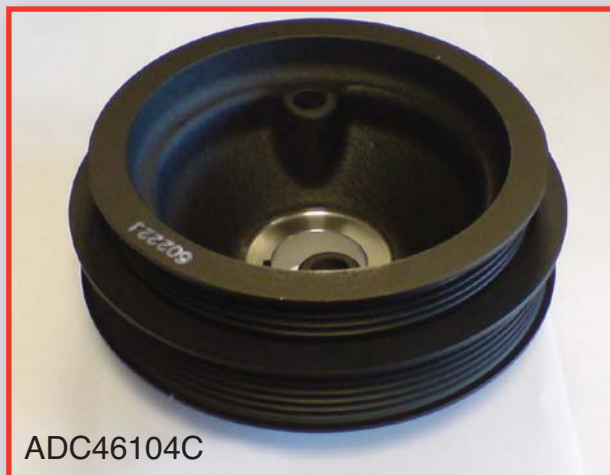
ADC46104C

We have been made aware that the Crankshaft pulley fitted on the Import Mitsubishi FTO 2.0 model is prone to partial or full failure during its service life.

The Crankshaft pulley consists of two sections (Inner and outer), which are connected by a rubber damper.

This can in time slowly break up causing movement on the pulley.

If the Crankshaft pulley is operating with a worn rubber damper at high engine RPM, the pulley can oscillate and in extreme cases there is a possibility that the outer part of the pulley can come adrift.

This excessive movement can cause the timing belt cover to move inwards and damage the Crank Angle Sensor Blade. If this part is damaged, the blade will act like a "knife" against the timing belt, with the potential of causing catastrophic engine failure

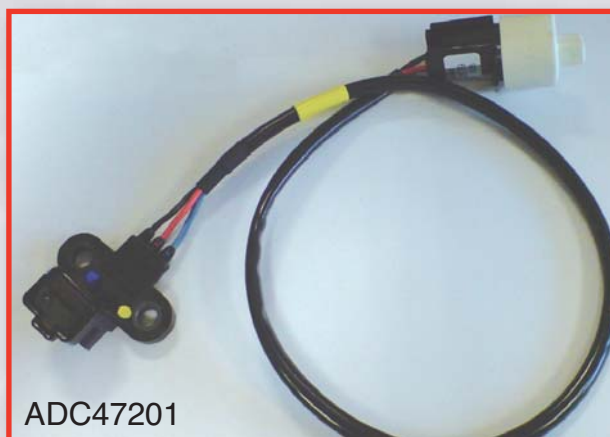
#### Linked part number: Crank Angle Sensor = ADC47201
