# Blue Print Bulletin

## Hyundai Lantra 1.6/1.8 KF Models Only (With G4CR or G4\*N DOHC engines) Caution when fitting ADC47514 Timing Belt

Date Issued: 01/07/02

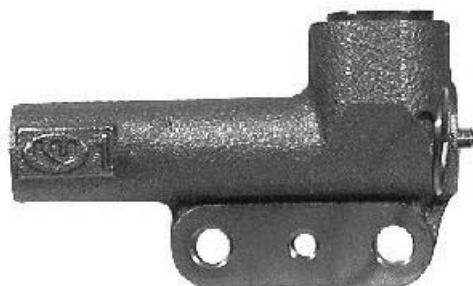
**ADG07607** Timing Belt Tensioner assembly

We have experienced several claims for 'timing belt failure' on the above model. Thorough investigation has identified the cause as insufficient timing belt operating tension, resulting from incorrect fitment or damage to the viscous tensioner.

This vehicle model is fitted with a manual AND viscous tensioner and it is ESSENTIAL that when fitting or tensioning the timing belt that the correct manufacturer's procedure is followed carefully. We recommend that a new viscous tensioner be fitted as a matter of course. However, if the original tensioner is to be used, the following additional care must be taken:

***Compress the viscous tensioner SLOWLY, otherwise the hydraulic valves inside the unit will become distorted and cause the tensioner to 'over relax' after fitment. Take two or three minutes (using a workshop vice with protected jaws) to compress the tensioner.***

***Once fitted, check that the viscous tensioner protrusion is correct (3.8 - 4.8mm). LEAVE FOR AT LEAST 15 MINUTES THEN RE-CHECK THE PROTRUSION. If the protrusion has decreased, replace the tensioner.***

***A third check of the tensioner protrusion or belt tension is advisable after a longer period.***

Blue Print recommend that the tensioner is replaced as a matter of course. If you have any doubt about the condition of the original viscous tensioner, it should also be replaced.
