# Technical Bulletin

## ADM59860 - Expansion Tank

Applications: Mazda RX8

## Mazda RX8 coolant light on when level is correct?

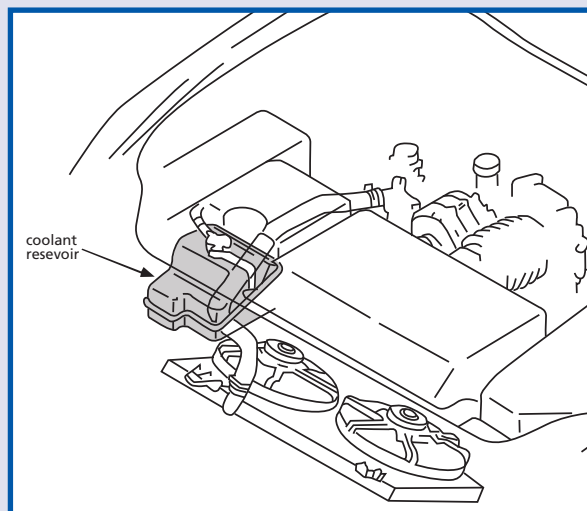
The coolant level sensor float is a common failing part on the Mazda RX8.

This is caused by surface deterioration of the sensor float which allows it to absorb coolant, causing the float to sink and give a false reading.

The coolant level light on the dashboard either stays on or flashes indicating a low coolant level, even when the coolant level is actually correct.

The sensor and float are not available separately, meaning the only permanent repair is to replace the complete Expansion Tank assembly.

Blue Print now supplies an OEM quality **Expansion Tank** with a revised specification coolant level sensor float – **ADM59860** – which is covered by Blue Print's comprehensive Three Year Warranty.

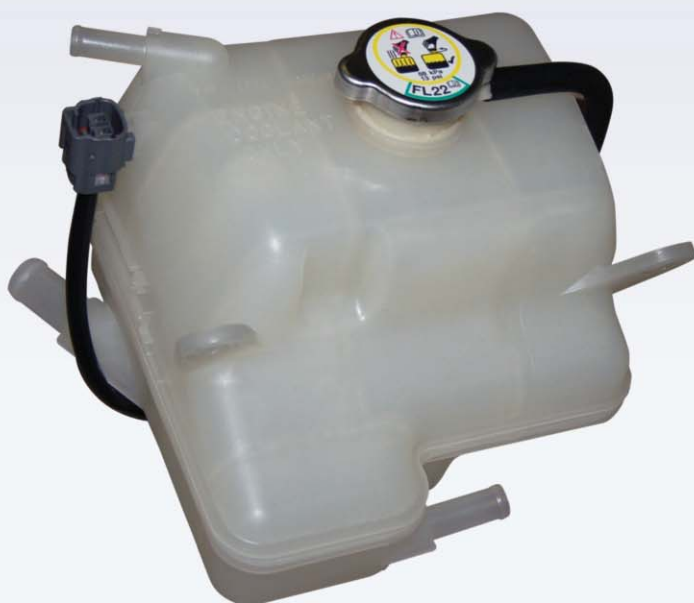
**Note:** Care is required when removing the coolant hose shown in the picture below, in order to avoid damage to the outlet on the radiator.
