Blue Print Bulletin

ADZ91107 and ADZ91113 Alternators

Date Issued: 01/11/01

We are aware of common vehicle faults associated with the charging system on Vauxhall applications using the Isuzu 1.5 and 1.7 diesel engines. The aim of this bulletin is to allow the correct diagnosis prior to replacing the alternator, and to assist in the prevention of further problems.

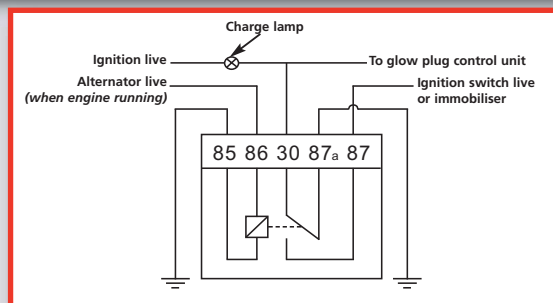
fig 1. - Charge Lamp Relay circuit

It is our experience that the *Charging Lamp Relay* is prone to failure. The relay controls the dashboard charging light operation and alternator excitation. It also gives a signal to the diesel system self-diagnostics and glow plug control unit for post-glow operation.

A 'quick' and simple test involves separating the round 4-pin alternator loom connector (on the driver's side inner wing - see figs 9 & 10 overleaf). With the ignition on (and the immobiliser cleared, if applicable), give a fused positive feed to the relay energising wire. This wire is normally Yellow/Red (male connector, vehicle side) and will correspond to terminal 86 at the charge lamp relay. Alternatively, apply a fused feed directly to terminal 86 at the relay (under the same conditions) to eliminate a harness fault. (see figs 1,2 & 7 overleaf).

- ***We strongly recommend that the relay is changed as a matter of course when replacing the alternator, as it is possible for an internal alternator fault to damage the relay whilst in operation.***

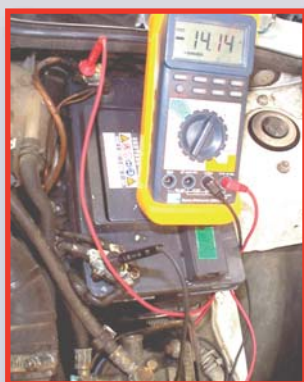
fig 3. - Charging voltage test

Test the battery voltage when the engine is running. The voltage should be between 13.7 and 14.7 volts at 1250 rpm. If it is within the above guidelines, the unit is charging correctly (see charge lamp relay test).

Please note that the battery must be in good condition and be fully charged with non-essential electrical loads switched off. A battery fault may cause overcharging, low voltage readings, or cause the alternator to 'burn out' after prolonged use.

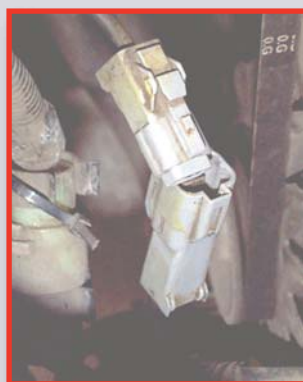
fig 4. - Main cable Lucar connector

There are two common failure points. Firstly the **large main alternator cable connector on the inner wing** is very susceptible to severe corrosion (see fig 4 overleaf of main 'Lucar' connector). Partial contact here will restrict or stop alternator charge from reaching the battery and in some cases cause the alternator to fail prematurely. This should be checked, cleaned or replaced as necessary.

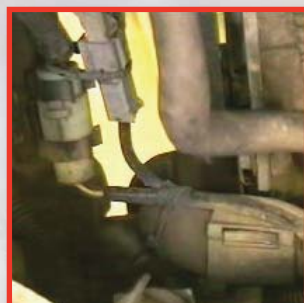
fig 8. - Alternator loom requiring continuity
test (inner wing multi plug to alternator)

Secondly, **the wires in the alternator loom** are prone to breakage (at the alternator end). This should be tested with an Ohm meter between the inner wing connection and the alternator plug. Please be aware that the wire positions in the connectors at each end of this loom will not be the same. The rubber 'bungs' in the back of the loom connectors should be removed to show the true wire location (see fig 10 overleaf). Also, ensure that the terminals in all of the connectors are 'tight' and have no evidence of corrosion.
