# Blue Print Top Tip

## Land Rover Defender / Discovery 1 - Clutch Kit or Clutch Release Fork Replacement

**Applicable References:** ADJ133302, ADJ133301, ADJ133006 & ADJ133007

**Applications:** 90/110/130 2.5DT 200/300 Tdi 1989>1998

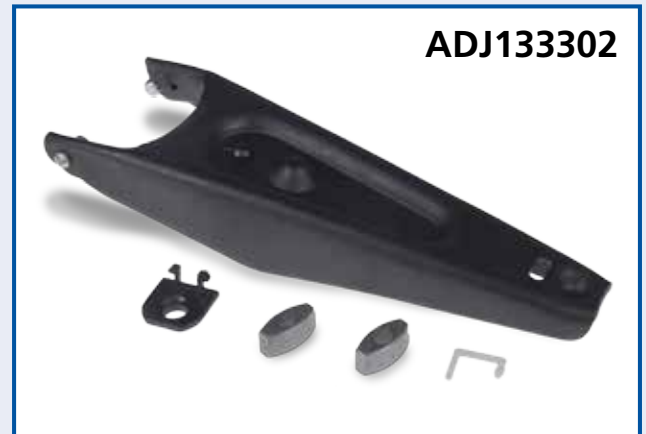
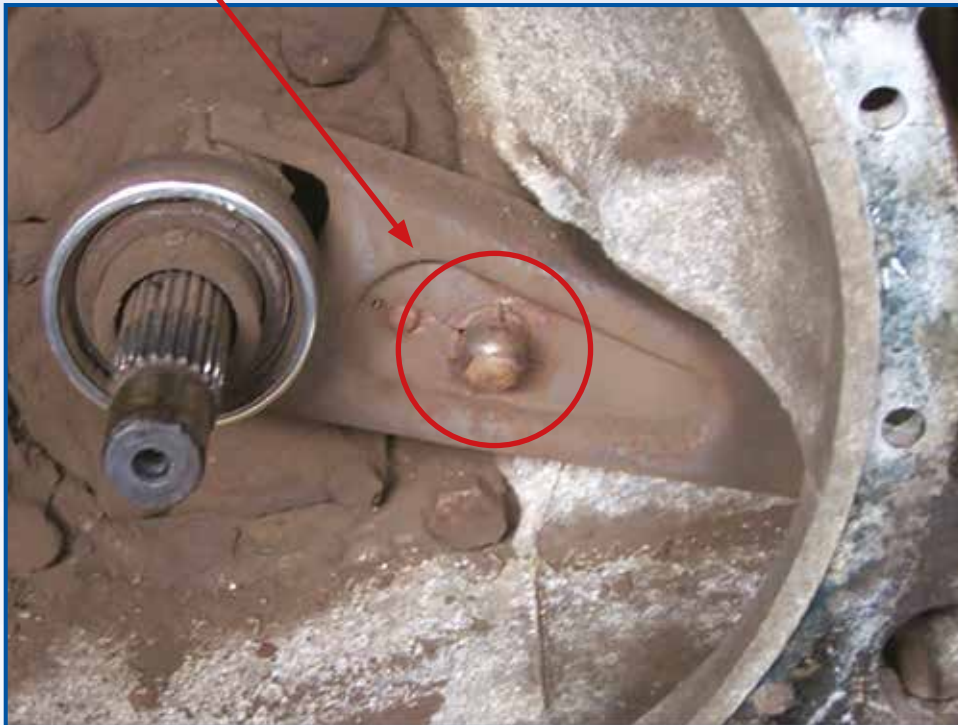
On removal of the gearbox, the clutch release fork may have worn through at the pivot point.

The clutch fork will need replacing. (**Blue Print Part No. ADJ133302**)

It is best practice to check the condition of the clutch assembly and spigot bush and replace as necessary whilst the gearbox is removed.

Ensure the pivot is lubricated with a small amount of suitable grease prior to re-assembly.
