Technical Bulletin

Product Information: ADN173506 Applications: Nissan Micra K12

Date Issued: 01/3/2011

Essential fitting information

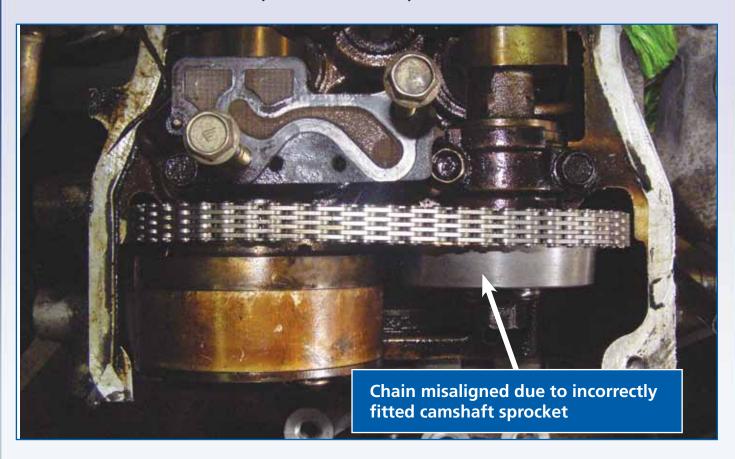
Our Research has shown that the camshaft sprocket on the Nissan Micra K12 (Petrol models) can be easily mis-aligned during the fitment process. Great care needs to be taken, to ensure that the camshaft sprocket is fully located squarely onto the camshaft.

If this is not adhered to, misalignment between the camshaft sprocket and the VVT (Variable Valve Timing) sprocket will result in a lateral force being exerted on the timing chain. This will cause the timing chain to move the tensioner guide rail off centre position, eventually resulting in the oil fed tensioner and tensioner guide rail becoming misaligned.

This sequence of events will result in the timing chain operating in a state of severe under tension, causing incorrect valve timing, which is likely to lead to catastrophic engine failure.
