Reconditioned EGR Valves

“Turn old into new” does not apply here

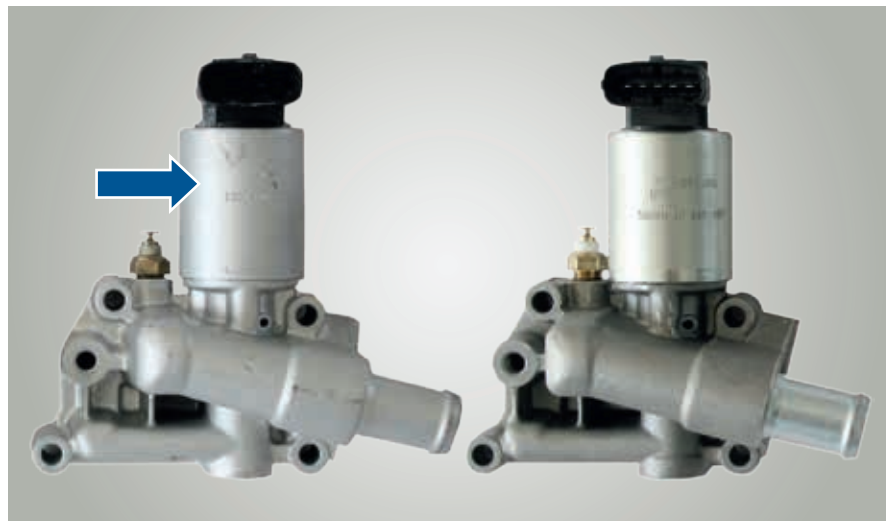
In the worst case, old EGR valves are only cleaned and painted. The result may look top-quality, but says nothing about the functioning of the EGR valve (Fig. 1).

Image 1: A painted EGR valve (arrow) looks like new – but it is not.

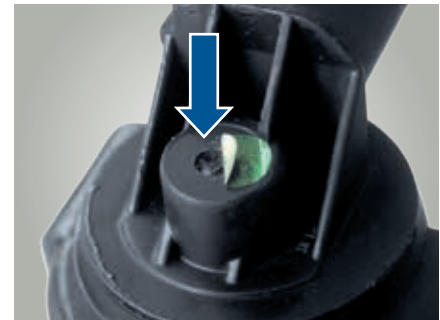
Image 2: For reconditioning, the coil body was drilled open, the inside of the coil was pushed out and cleaned. After re-assembly, the bore was glued and covered with a sticker.

Coil and armature may have been damaged when they were pushed out. Water can enter through the hole and cause damage.

Image 2: This bore (arrow) can lead to water penetration and failure.

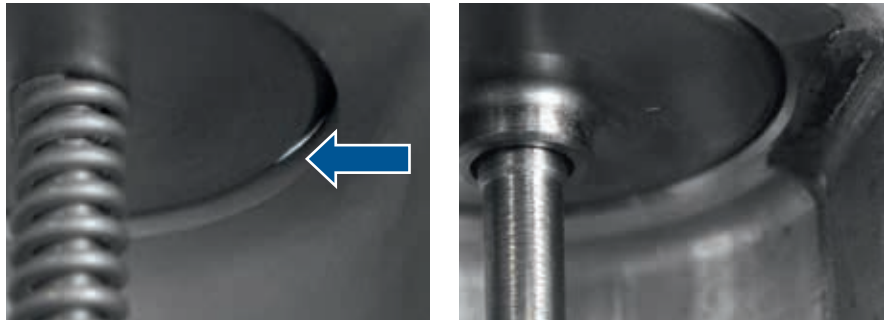
Often, conditioned parts of different generations of an EGR valve can be supplemented with components that have been made by the reconditioner himself. This may cause the processed EGR valves to no longer fit for the intended vehicle application, or they may cause problems in the vehicle. The original, especially shaped valve seat is supposed to provide a tight seal.

Image 3: A leaky valve seat (arrow) causes problems.

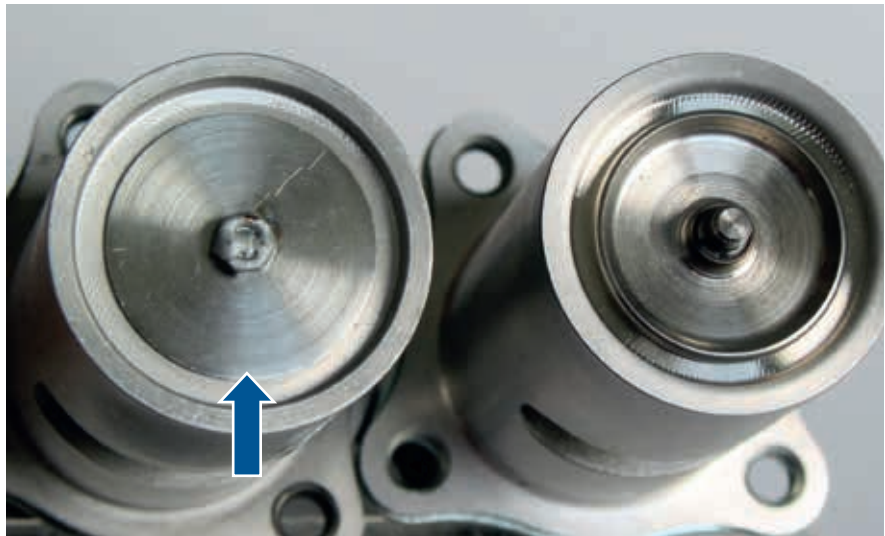
If the valve head is replaced by a simple plate as in image 4, correct sealing is no longer provided. This leads to uncontrolled exhaust gas recirculation. Out-of-true idling, poor acceleration, or even limp home function can be the result.

Image 4: A welded-on metal plate (arrow) is not a substitute for a valve seat.

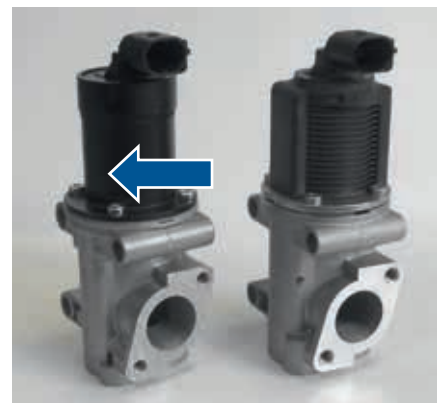
Coil housings especially optimized for heat dissipation are replaced with simple turned parts (image 5). The characteristic on reconditioned EGR valves informs only about the state of the coil, not the flow or tightness.

Image 5: Original coil body was replaced by simple turned part (arrow).

We recommend using only new EGR valves. The potential price advantage with reconditioned EGR valves compared to a new part is eliminated by a shortened product life and thus more frequent servicing costs.
