# Mercedes-Benz W211 variable intake manifold

## Fracture on cam control mechanism

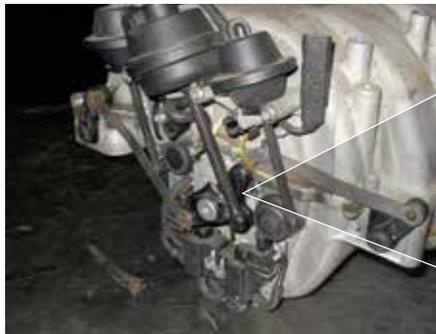
If oil leaks out here and drips onto the cam control mechanism, its plastic material can become porous and break.

*Damage symptoms: Fracture on cam control mechanism*

- If oil leaks out, the plastic line must be replaced immediately with an aluminium line.
- If the cam control mechanism is already damaged, the intake manifold should be replaced.

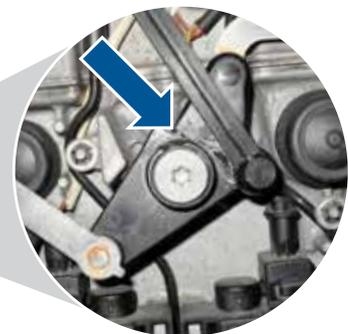
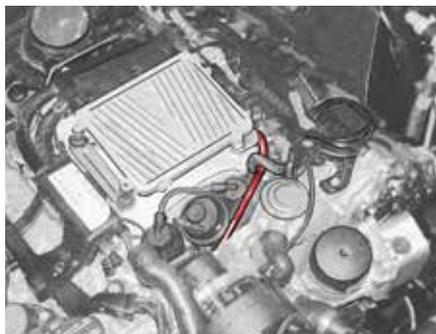
The cause of the damage is not the intake manifold but a leaky line in the engine ventilation system. The line in the engine ventilation system runs above the cam control mechanism on the intake manifold. The line originally fitted in the engine ventilation system can start to leak with age or load.

*Engine compartment W211 with engine ventilation system line (highlighted)*

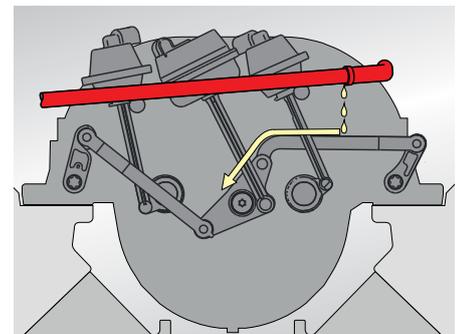
*Cause of damage: Oil leaking from line of engine ventilation system (highlighted) and damaging cam control mechanism*
