## LuK Service Info

# LuK GearBox

## Diagnosis of the twin-bearing assembly - 02T transmission VAG

Transmission type: 02T

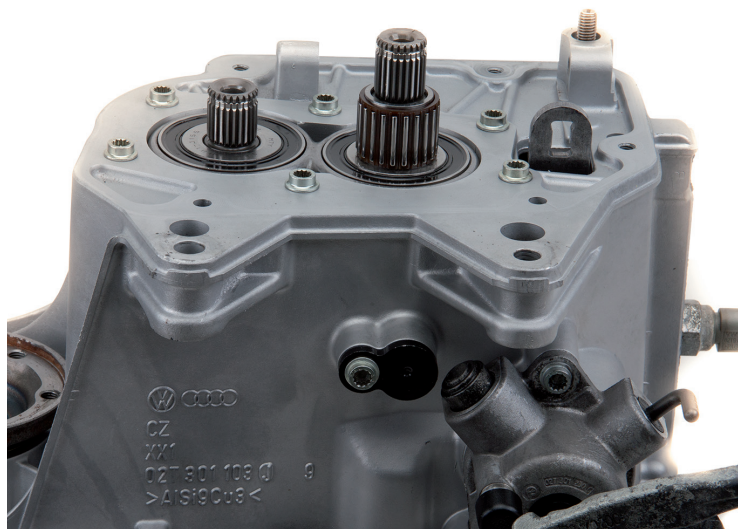
A defective twin-bearing mounting plate assembly shows no sign of damage on the outside. It usually makes a slight noise, (e.g. whirring, rattling or grinding) whilst the transmission still operates perfectly.

Twin-bearing mounting plate assembly and needle bearings of a 02T transmission

The increased friction in a defective twin-bearing mounting plate assembly generates excess heat. This can destroy the needle bearing of the positioned 5th gear, and the gear can no longer be engaged. The same thing can happen if there is not enough oil available at the 5th gear. In both cases, the cage is damaged and the needles scatter around the shaft.

1. Operate the transmission until it is warmed up.
2. With the clutch engaged and the transmission in neutral, increase the engine speed to approximately 4000 rpm.
3. Step on the clutch pedal and shut the engine off at the same time.
4. If you hear rattling noises which change as the speed of the transmission input shaft slows, the twin-bearing mounting plate assembly is defective.
