Technical *data*

Timing belt CT 881 K2/K4 by the example of Ford 1.25 16V/ 1.4 16 V/
1.6 16 V – Various models from 4/97

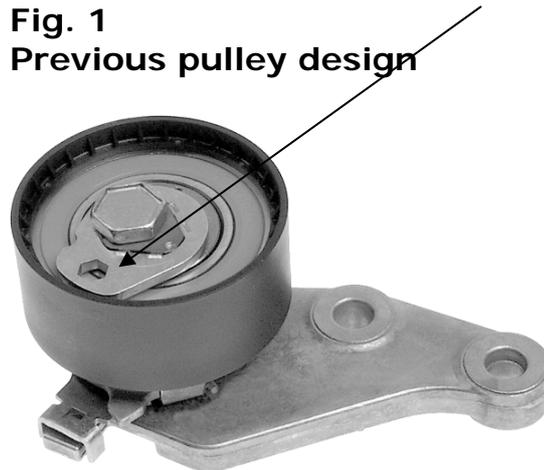
Fig. 1
Previous pulley design

The tension pulley delivered in the kit is designed differently from the pulley previously installed in the vehicle.
(Eccentric adjustment up to pointer alignment using an Allen key)

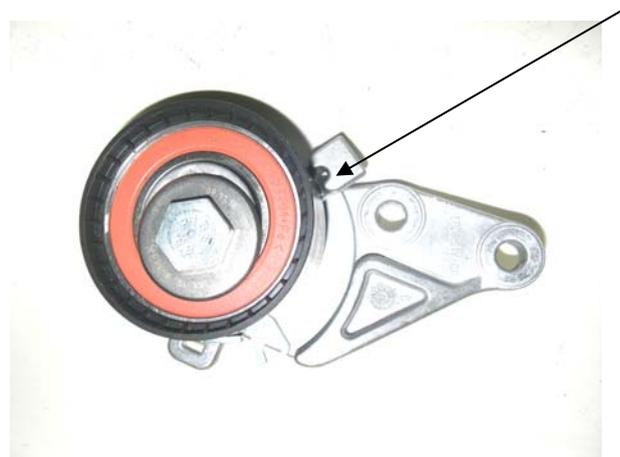
Fig. 2
New design

According to the manufacturer, the new version must be installed instead of the previous one when belts are changed.

The new pulley is now equipped with a pre-mounted cotter pin and can be installed directly. After all components have been installed, the safety cotter pin is just pulled and the tension is set automatically.
