### Timing belt kit CT1134K1/WP1/WP2 for Audi, Seat, Skoda and VW. Various 2.0 TDI Common Rail models, 1st generation

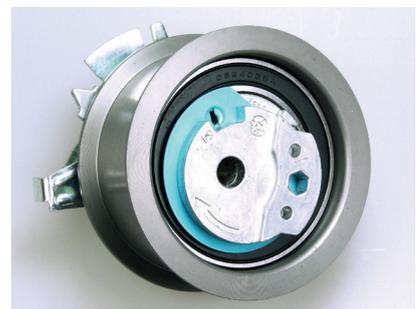
Fig. 1  
Previous pulley design

The supplied V56340 tensioning pulley differs visually from the pulley installed in the vehicle and seems as though it cannot be correctly tensioned.

In the original equipment, the pulley design as in Fig. 1 is installed. A slightly modified tensioning pulley is supplied for the aftermarket – see Fig. 2.
