If the gearbox is not connected to the engine with the necessary care, the clutch drive disc for the power take off can be bent and forced against the torsion damper of the clutch disc.

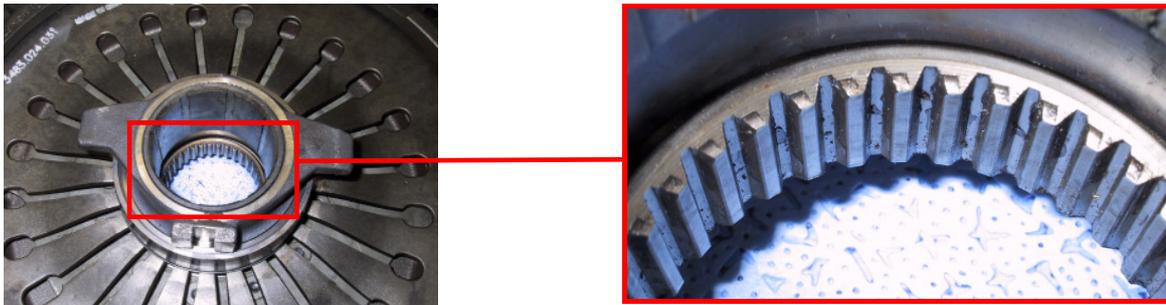
This occurs when the teeth of the drive sleeve do not engage in the hub grooves, but are pushed against the front face of the hub splines. The drive disc is pushed towards the clutch disc in the process.

Possibly results could be a contact with the torsional damper of the clutch disc, resulting in spline damage (see figures above).

If the drive disc is damaged, the clutch cannot be fully disengaged and noise occurs.

Important information for assembly of clutch and gearbox:

- Before mounting the gearbox, the clutch disc must be correctly centered.
- When mounting the gearbox, it must be ensured that the teeth on the drive shaft engage correctly in the teeth of the drive sleeve.

For this purpose, connect compressed-air to the auxiliary drive and allow to run. When the drive sleeve rotates, the hub splines are positioned correctly.

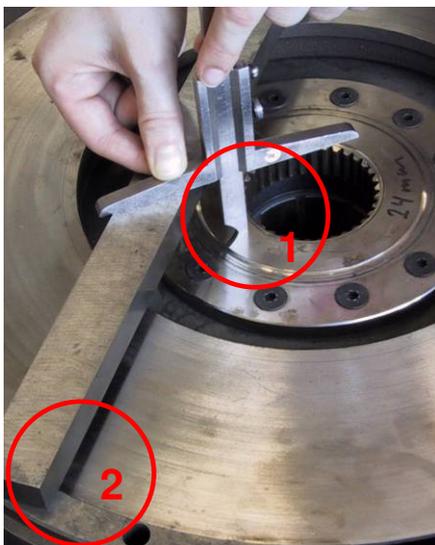
Test options for assembly damage :

- Check dimension with a suitable tool as illustrated
- The distance between the hub / front face of the drive disc (1) and the contact surface between housing and flywheel (2) must be about
 - 32 mm for clutch covers 3483 024 031 and
 - 23 mm for clutch covers 3483 019 031.
