Blue Print Top Tip

Land Rover Defender / Discovery 1 - Clutch Kit or Clutch Release Fork Replacement

Applicable References: ADJ133302, ADJ133301, ADJ133006 & ADJ133007

Applications: 90/110/130 2.5DT 200/300 Tdi 1989>1998

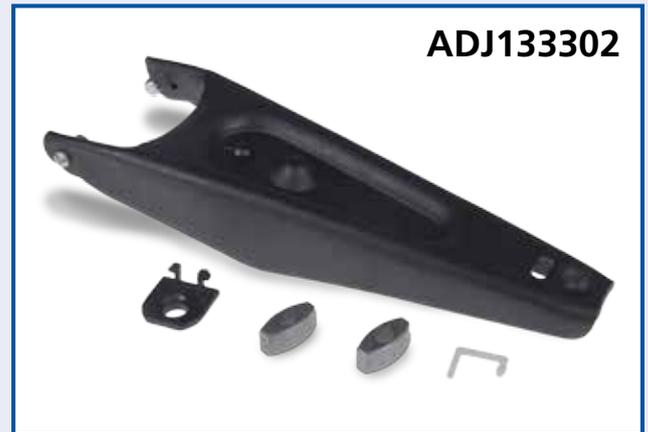
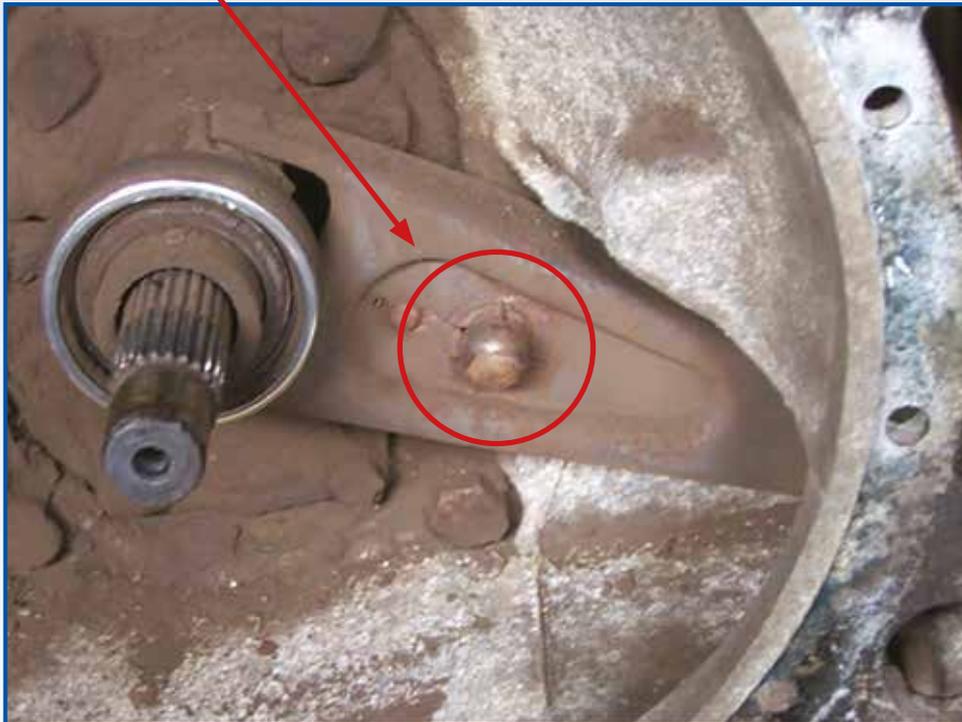
On removal of the gearbox, the clutch release fork may have worn through at the pivot point.

The clutch fork will need replacing. (**Blue Print Part No. ADJ133302**)

It is best practice to check the condition of the clutch assembly and spigot bush and replace as necessary whilst the gearbox is removed.

Ensure the pivot is lubricated with a small amount of suitable grease prior to re-assembly.
