Efficient repair solution for Mercedes Benz Sprinter, Vito, Viano and VW Crafter, LT!

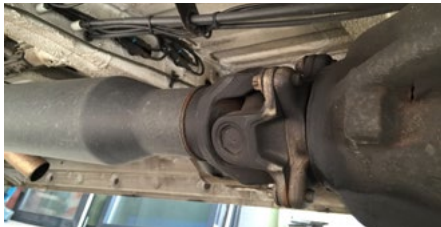
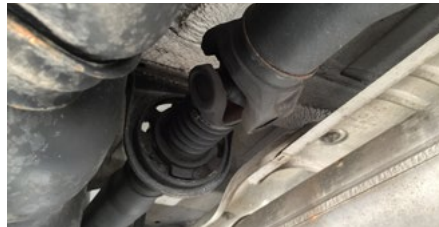
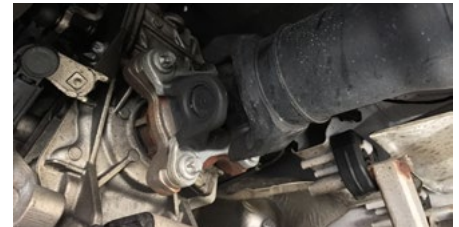
Initial warning signs that indicate trouble and faults in the area of the propshaft:

- Noises coming from the direction of the vehicle's underbody, mostly at specific revs/speeds
- Unusual vibrations
- Knocking noises in gear change situations

The reason for this may be a faulty or worn universal joint. This may result in complete failure of the power train. Always replace the joint if in doubt.

At febi bilstein we have a reasonably priced and technically perfect repair solution for you and your customer.

You only replace the universal joints.

Often in online parts identification tools, several universal joints are assigned to a vehicle type. Before ordering parts we recommend matching the dimensions of the old universal joint. To do this, please measure the length of the universal joint with lightly pressed-on bearings (a) and also the outside diameter of one of the four caps (b).
