## KB950.00

### Removal / Installation recommendations

**BMW:** M3 (E30, E36), Series 3 (E30, E36, E46), Z1 (E30), Z3 (E36)

### IDENTIFICATION OF SUSPENSION BEARING KIT KB950.00

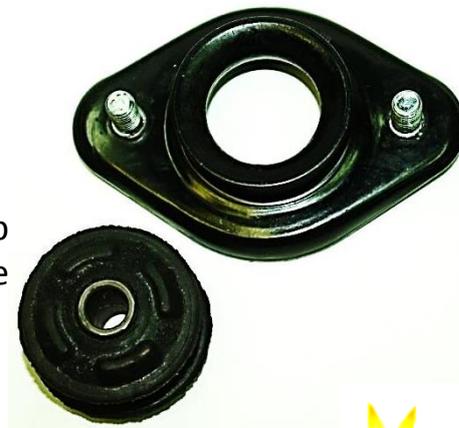
### THE RUBBER ISOLATOR BUSH SEPERATING FROM THE METAL SUPPORT

**Incorrect assembly of the kits components.**

This failure is common when the shock absorber strut sub assembly is not correctly assembled ie, parts fitted the wrong way around or totally missed out.

- When replacing the insulator, make sure the two mounting cups (upper and lower) are retained as they are needed to reassemble the strut top mounting.
- Make sure the cups and reinstalled the correct way around.
