Blue Print Bulletin

Toyota Throttle Position Sensor (Potentiometer)

Date Issued: 01/02/07

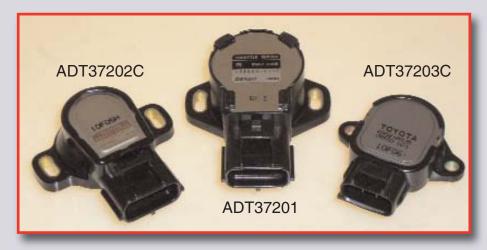
A malfunction with this should register a fault code within the ECU diagnostic memory, however the engine warning lamp (MIL) may not necessarily illuminate. It may be accompanied by other codes such as 'Lean Mixture'. If the unit uses carbon tracks, dirt or carbon deposits will badly affect the performance (see images).

Specialist equipment is not needed to retrieve fault codes stored in the ECU memory, however the relevant Toyota procedure should be followed to obtain them (using the 'blink' code from the engine warning lamp). The sensor unit may be tested using resistance measurements between sensor terminals or by a suitable diagnostic tool/oscilloscope. As failure is often a result of wear at certain throttle positions, we recommend the use of specialist equipment.

Remember that any fault codes should be cleared from the ECU memory after the repair has been carried out, and that the final position of the sensor must be set correctly prior to testing or after its replacement (please refer to the workshop manual or technical information for your specific vehicle model).
