Oil-stop cable

» KNOW+HOW

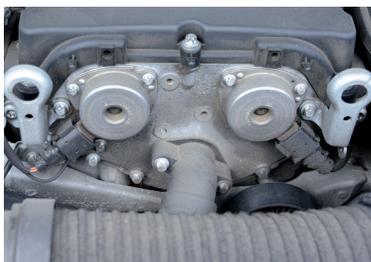
The problem? Short-circuiting, failure of the vehicle electronics

In all Mercedes-Benz petrol engines with engine codes M111 and M271, damage to the control unit and individual parts of the camshaft sensor can be traced back to a design flaw.

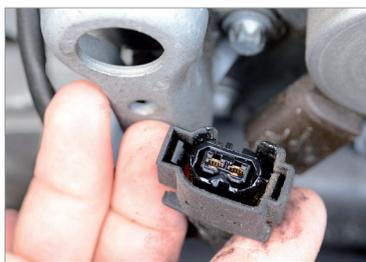
The cause? Oil leaking from the camshaft-sensor plug

As the result of a design flaw, oil is able to leak out of the camshaft-sensor plug and infiltrate the length of the cable harness to reach the control unit due to the capillary effect (which describes how liquids spread out in tight gaps, tubes and pipes).
