NUMBER 014

Fiat 1.6 petrol engines / Synchronous Drive / Tensioner Info.

GATES REFERENCE:	5432XS and related kits.

Technical Bulletin

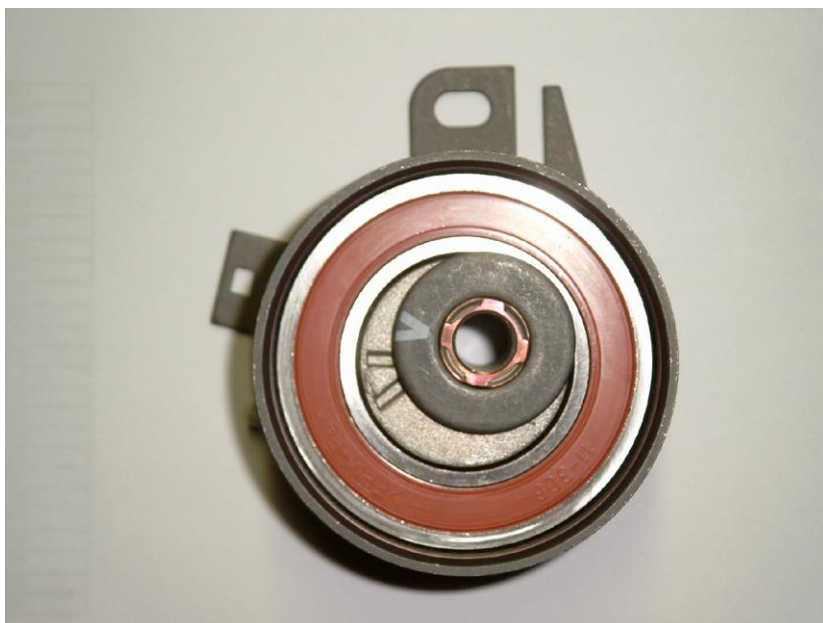
Fig. 1 tensioner in kit until 08/2004	OE ref. 46792898
Fig. 2 tensioner in kit from 09/2004 until 11/2005	OE ref. 46416489
Fig. 3 tensioner in kit as of 12/2005	OE ref. 71734799

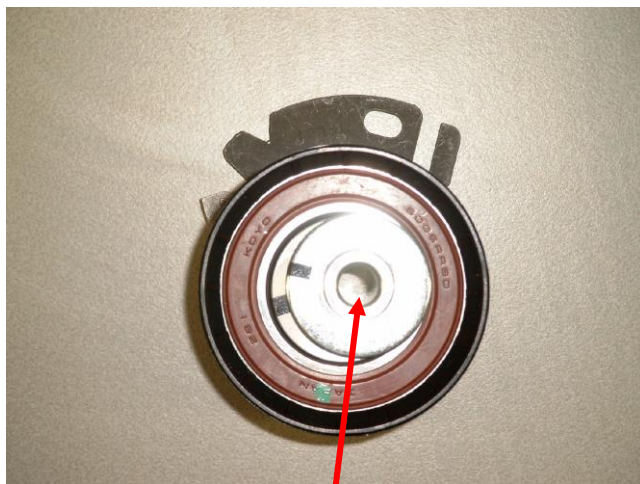
Fig. 3

A

The latest version that is now used on OE(S) level replaces the two previous parts.

It may be possible that the tensioner on the car is still an older model. There is no problem to install the latest version tensioner with the old stud and nut. Although the depth of the fixing hole (A) of the tensioner is deeper and the stud stays the same, there is still enough room on the stud to fix the nut properly, see Fig. 5 (B).

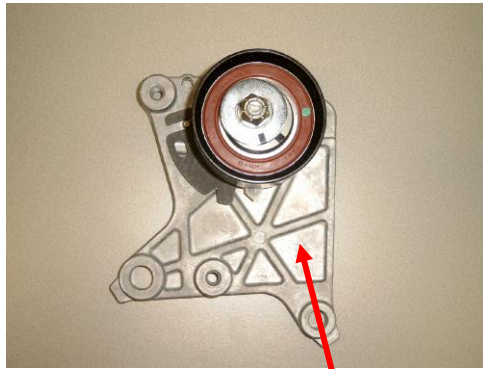
C

Fig. 4 and Fig. 5 show the latest version of the tensioner fixed on the bracket.

Normally this bracket (C) is mounted on the engine block and does not have to be removed.

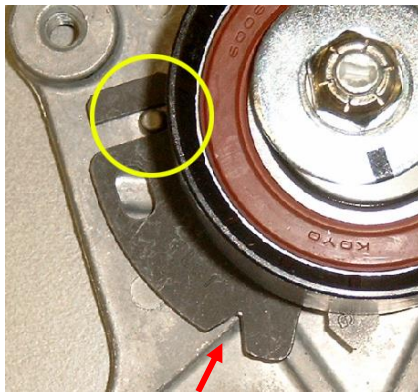
Fig. 6

E

To lock the tensioner, position the open oblong hole in the base plate of the tensioner on the pin on the bracket (Fig. 6).

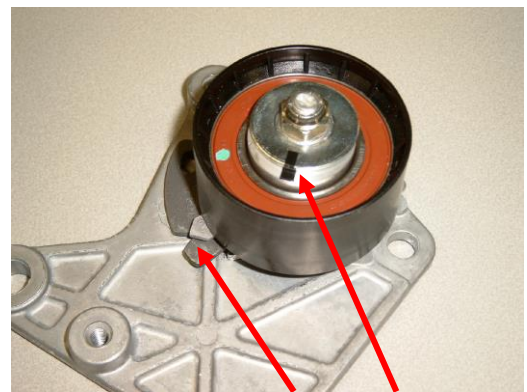
Fig. 7

D

F

When the belt and the tensioner are replaced, following the installation instructions inserted in the kit, and after two engine revolutions, the pointer (D) has to be in the middle of the "V" in the base plate of the tensioner (E). At that moment the two black marks (F) will also be aligned. Only then the tensioner is correctly installed.

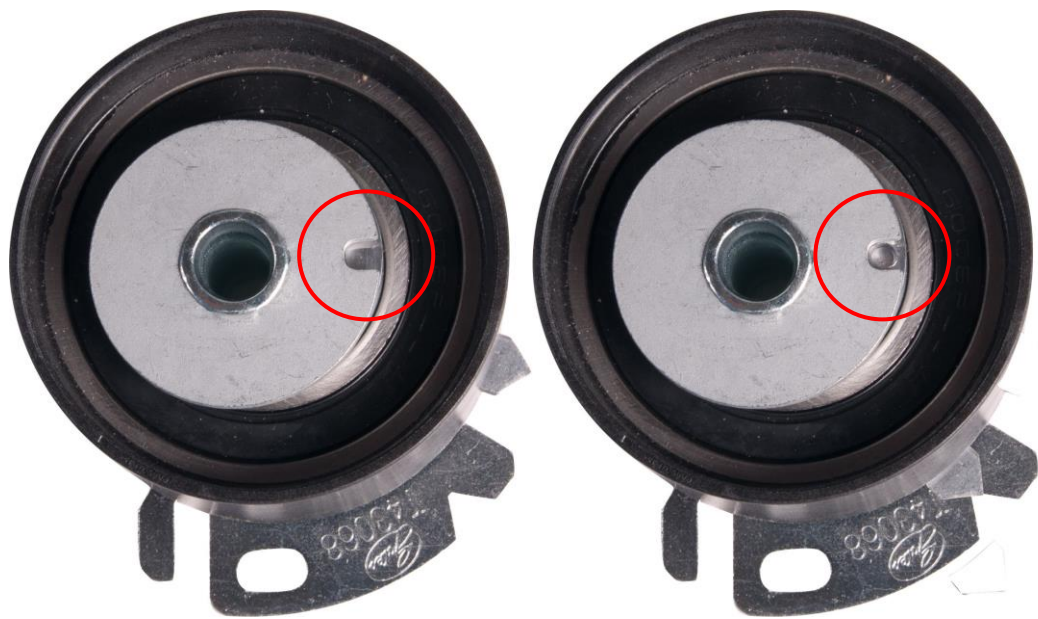
Fig. 8

In the actual kits you find the tensioner (Fig. 8) on which we have changed the black marks into a new positioning system. The indicator of the correct position is a point in relief.

Not in the correct position:

In the correct position:
