T43090

VAG 1.0 16V AST / AVZ & 1.4 16V AFH

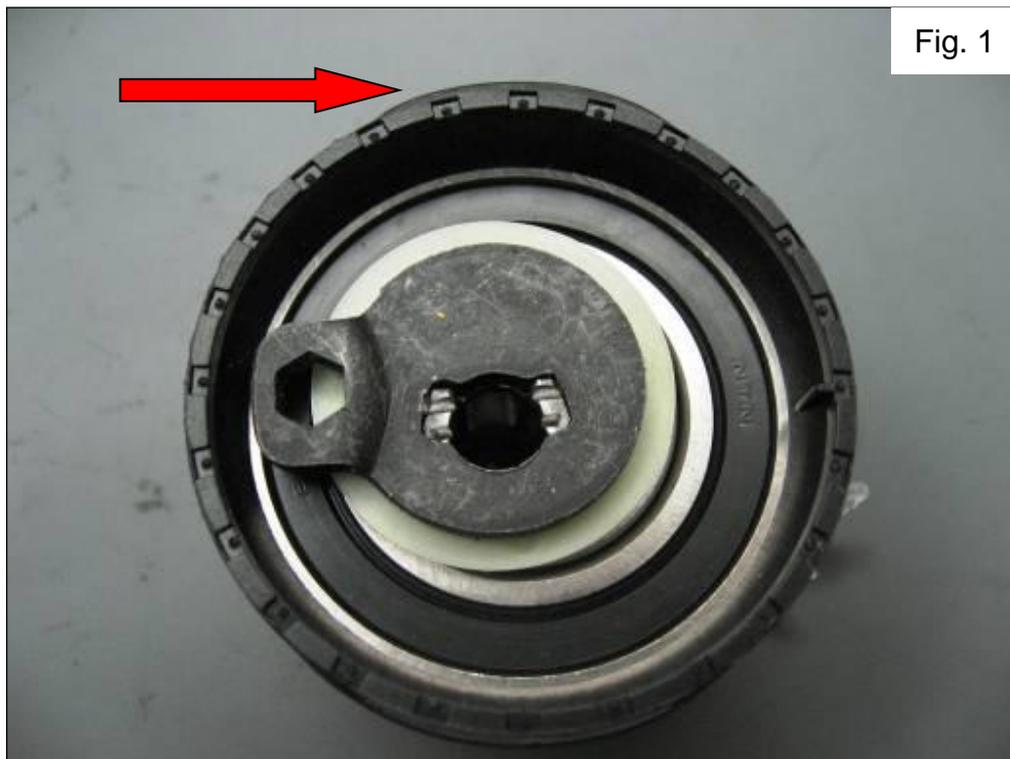
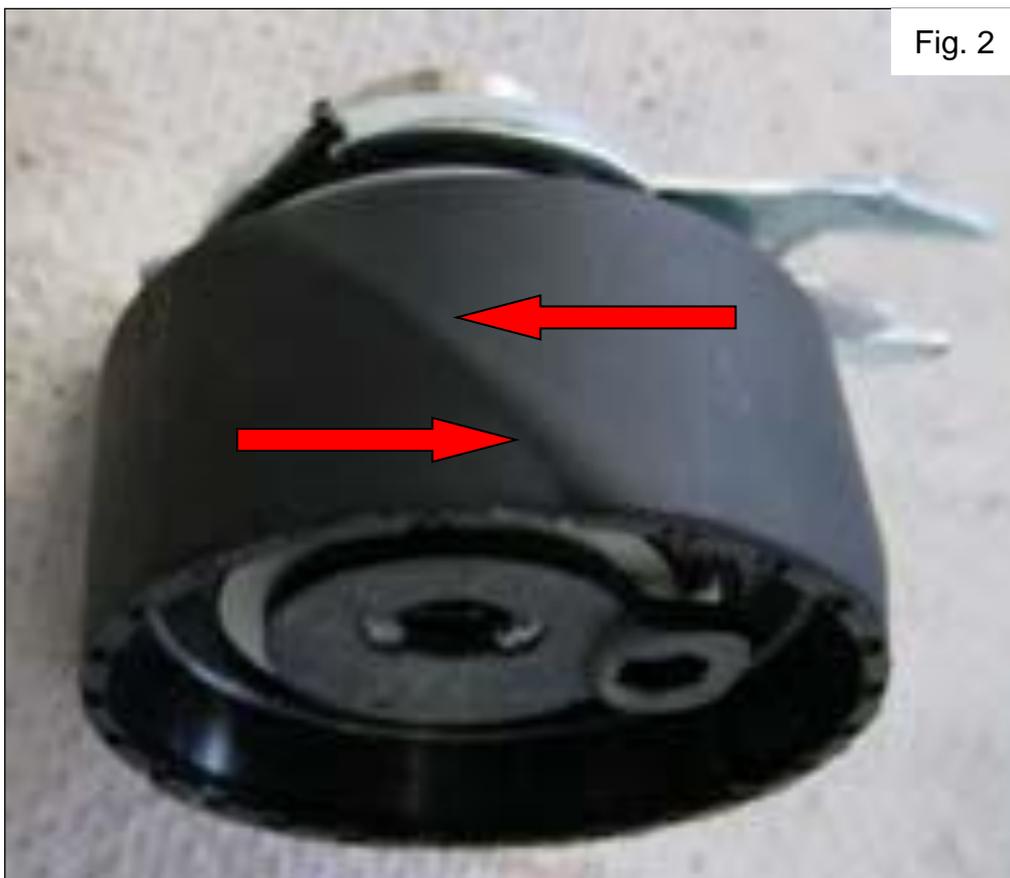
The tensioner pulley has a "ridged" surface (Fig. 1 and 2).

This is intentional. These "ridges" are designed to help reduce belt noise generated by surface contact.

When replacing the timing belt, ensure that a new "ridged" tensioner is installed at the same time.
