OAP7144

Opel & Vauxhall 1.4 Petrol

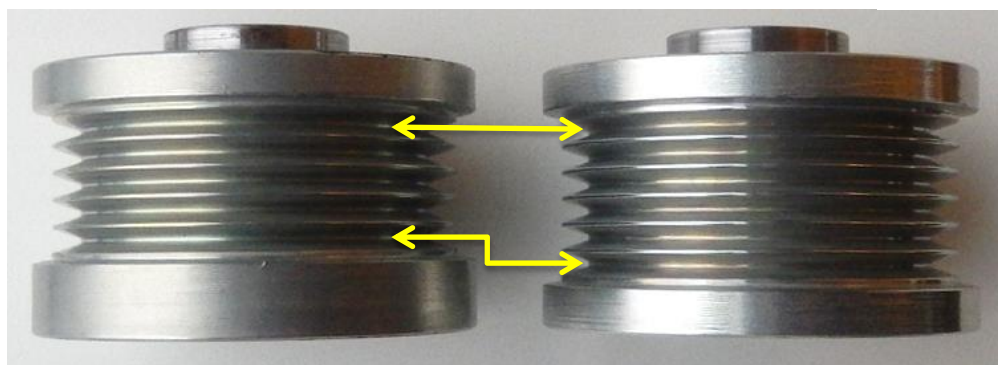
Fig. 1

On certain Opel/Vauxhall engines (codes: A14NEL, A14NET, A14XEL, A14XER) the belts may have 5 or 6 ribs while the pulleys may have 5 or 6 grooves. It depends on the manufacturing date of the car. Gates recommends replacement of a 5 groove OAP (Fig.1 left side) with the 6-grooved OAP7144 (Fig. 1 right side).
