# febiEXAKT

## Guide rail for timing chain

**febi No. 25467**

VW | Škoda | Seat 1.2 12V-Motoren  
(AZQ, BME, BZG)

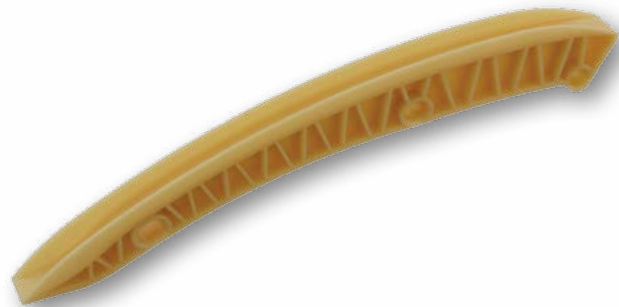
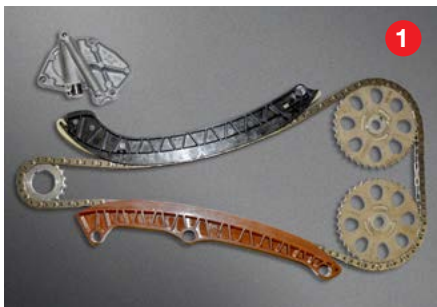
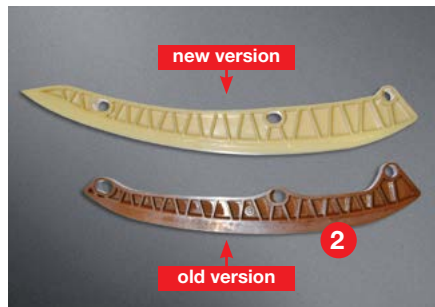
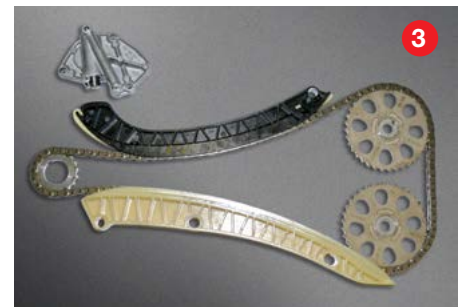
The timing chain jumps even though all the components are properly fitted. Jumping of the chain can cause the engine to run unevenly and can even lead to engine damage.

The vehicle manufacturer has installed a guide rail that is too short. The result is that the chain can jump when starting or switching off the engine.

The guide rail has been adjusted. It is now longer and consequently ensures perfect guidance of the chain under all conditions and prevents jumping.

**Recommendation:** Replace all components (such as guide rails, chain tensioner, possibly gear wheels) as a general rule when replacing timing chains to ensure perfect function over the chain's entire service life.
