## Cost-effective repair solutions!

## febi bilstein offers a unique repair solution for the aftermarket!

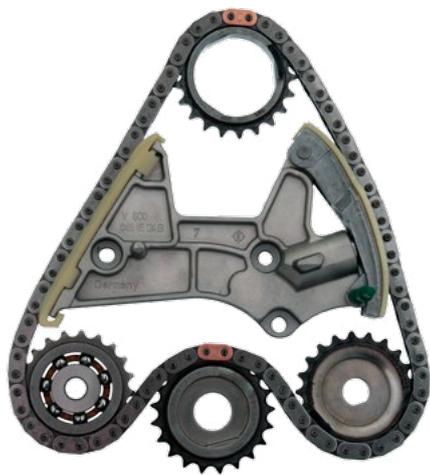
**Crankshaft gear wheel  
febi no. 40113**

In 1.4 TDI 3-cylinder engines by VW, the balancer shaft and the oil pump are mounted on the ladder-type frame and are driven by a chain from the crankshaft. The components of the balancer shaft drive are susceptible to wear due to high loads and exceeding the oil change intervals. In the worst case, the chain may break, resulting in serious engine damage.

The crankshaft gearwheel is not available separately from the manufacturer. It can only be ordered with the crankshaft which makes the repair expensive.

Other components of the balancer shaft drive are also frequently affected by wear. For this reason, febi bilstein offers two repair kits: febi 32266 without and febi 43667 with crankshaft gearwheel. This combination enables a professional repair and avoids potential complaints. That saves time and money for both workshop and customer!
