Checking the tensioning and deflecting pulleys during the inspection

Audi, Seat, Skoda, Volkswagen

Engine: 1.4; 1.4 16V
1.6; 1.6 16V

INA 0003

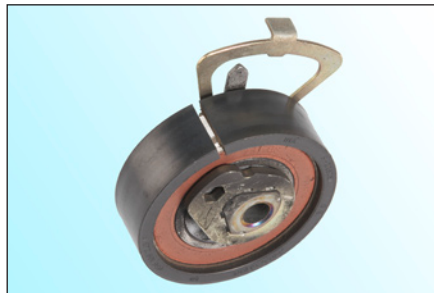
Fig. 1

With reference to several models produced by the manufacturers named above with 8 V and 16 V engines, in a few instances the toothed belt tensioning pulley (**fig. 1**) and/or the toothed belt deflecting pulley (**fig. 2**) may show evidence of damage in the area of the pulley running surface.

Damage to the pulley running surface may, under some circumstances, lead to damage to the toothed belt and, subsequently, to breaking of the toothed belt.

We recommend that all belt drive components are visually inspected at 30,000 km or, at the very latest, at 60,000 km.

Should you discover damage to the pulley running surfaces, replace the damaged components.
