SI 0106
For technical personnel only!
1/4

SERVICE INFORMATION

SECONDARY AIR SYSTEM

DESIGN, COMPONENTS, TROUBLESHOOTING

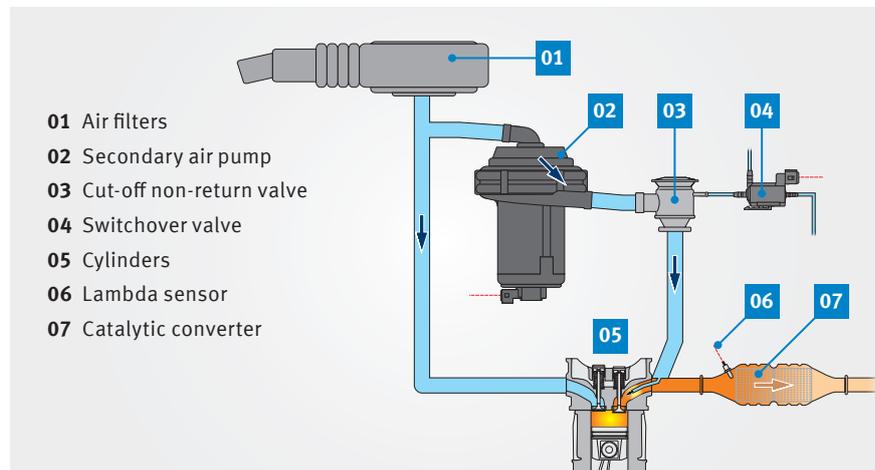
Block diagram of secondary air system (pneumatically actuated)

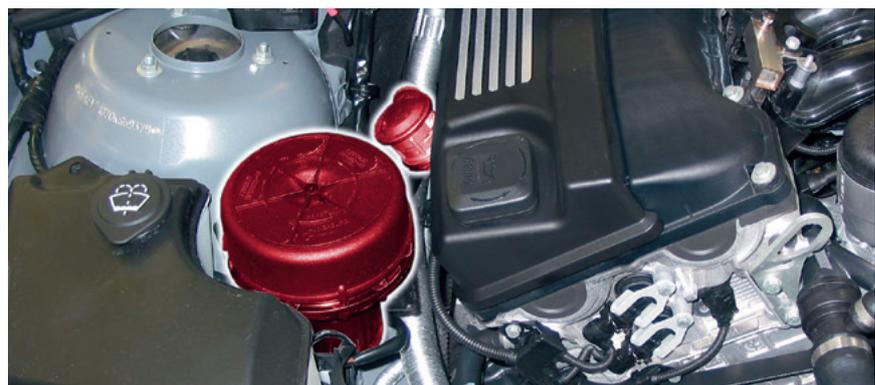
Secondary air valve and secondary air pump in BMW E46 (highlighted)

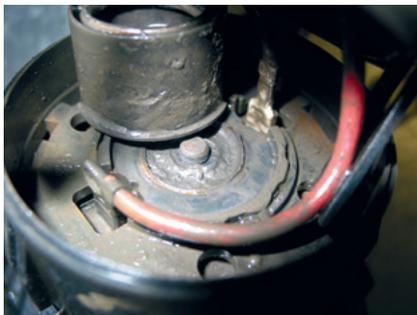
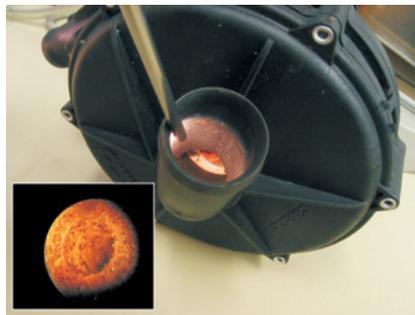
Open secondary air valve
Left: Damage caused by exhaust gas condensate
Right: New condition

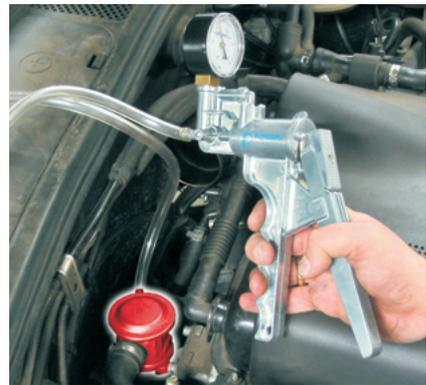
Checking a secondary air valve with a vacuum hand pump

Following removal, operation of a vacuum-controlled secondary air valve can be checked using a vacuum hand pump:

- The secondary air valve must be replaced if it does not open on applying vacuum.
- If the secondary air valve opens on applying vacuum, the solenoid actuation valve (switchover valve) and the vacuum hoses must be checked.
- The secondary air valve diaphragm is leaking if the vacuum applied with the vacuum hand pump decreases.
- Deposits on the side facing the secondary air pump (finger test, Fig.) are an indication of non-return valve leakage.
- To check, unfasten the connection hose between the secondary air pump and secondary air valve.

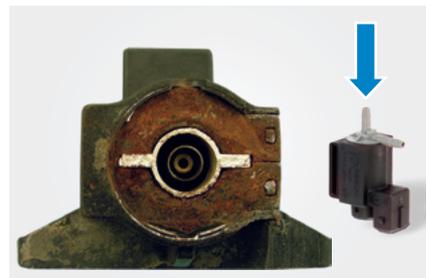
Corroded switchover valve (open)

The switchover valve remains energised for the blowing in of secondary air (cold start phase).

The switchover valve is open when energised and closed when de-energised.

- A vacuum hand pump can be used to check for opening and leakage.
- During blowing in of secondary air, the on-board voltage must be applied to the plug of the switchover valve. If not, an electrical fault has occurred and must be localised with the help of a circuit diagram.
