**VAG 1.4 & 1.6 16V / Synchronous Drive / Installation Info.**

<b>GATES REFERENCE:</b>	<b>5565XS &amp; related kits.</b>	
<b>MAKE:</b>	AUDI, SEAT, SKODA, VOLKSWAGEN.	
<b>MODEL:</b>	Various.	
<b>MOTOR CODE:</b>	1.4 16V, 1.6 16V.

Technical Bulletin

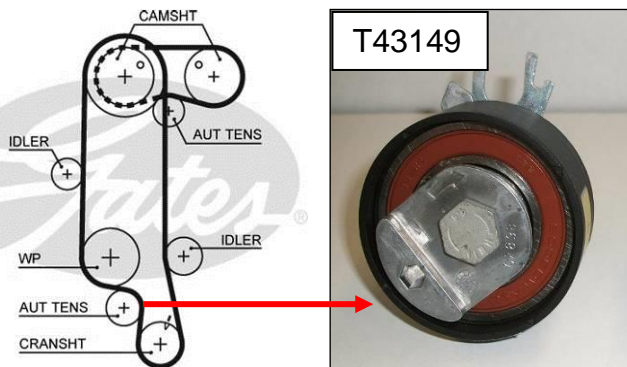
Fig. 1 shows the 2 different versions of the automatic tensioner (for the main drive) to be found in our kits. They are interchangeable.

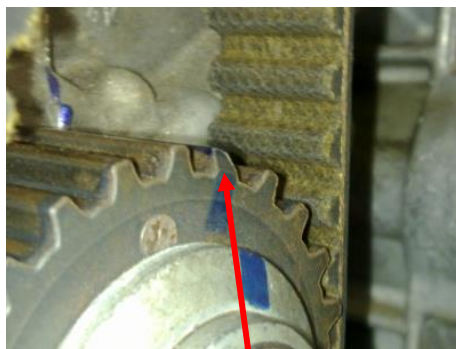
Fig. 12

Slanted tooth

Put the engine at its Top Dead Centre (TDC).  
Slanted tooth of the crankshaft pulley (Fig. 12) has to be in line with right hand positioning rib (Fig. 13).

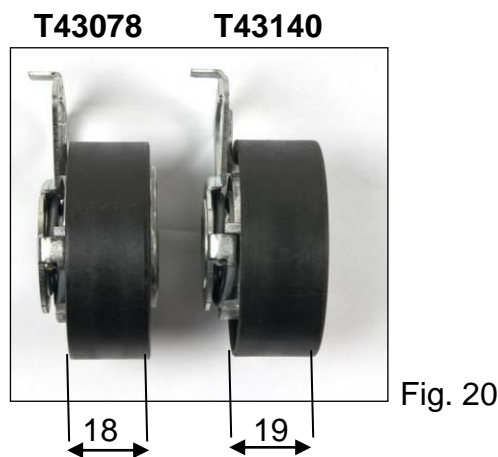
Fig. 20

The pulley width of the tensioner T43078 is 18 mm, for the T43140 the width is 19 mm (Fig. 20).

The main difference is to be found inside the tensioner. Requirements from OE on this tensioner resulted in two different "internal" constructions.

These tensioners are NOT interchangeable.

Check the online catalogue for the correct parts per application.
