## KB950.00

### Removal / Installation recommendations

**BMW:** M3 (E30, E36), Series 3 (E30, E36, E46), Z1 (E30), Z3 (E36)

### IDENTIFICATION OF SUSPENSION BEARING KIT KB950.00

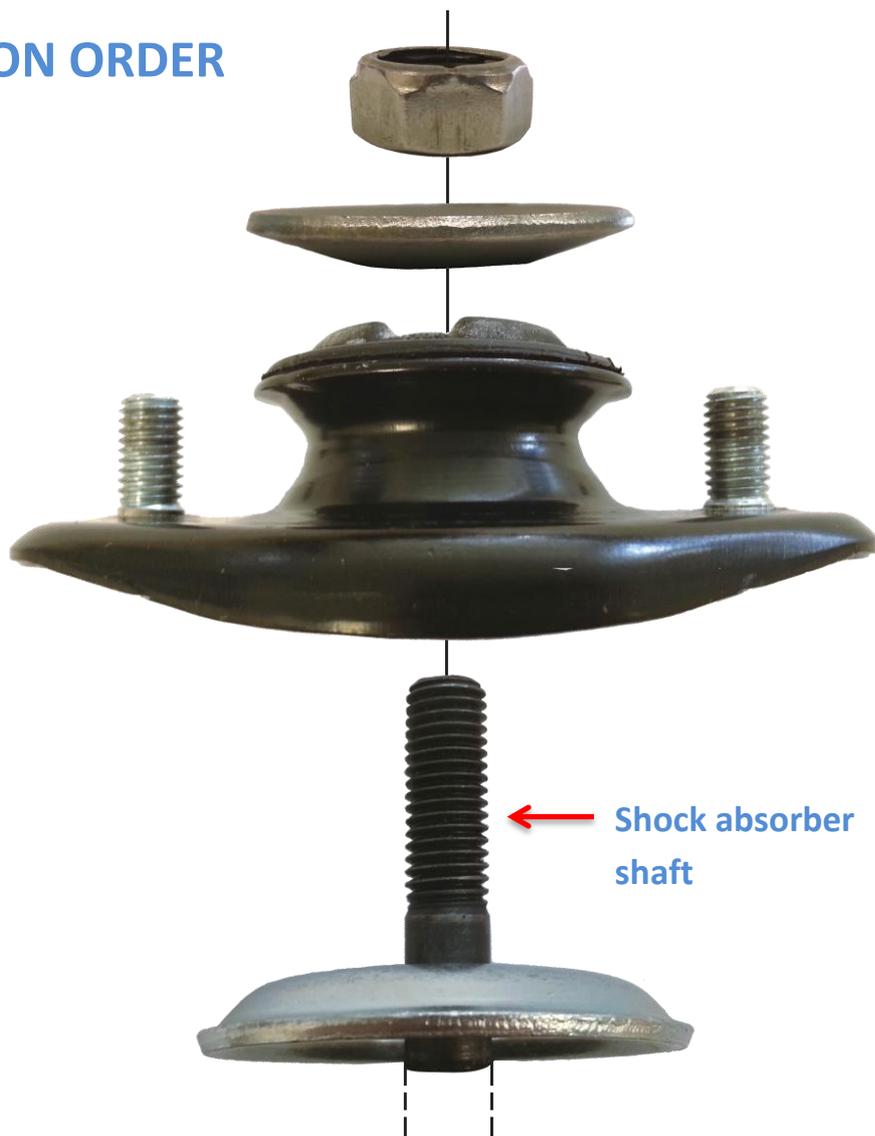
## INSTALLATION ORDER

**Do not change the installation orientation of the upper mounting cup (dished upwards)**

**Do not forget to re-install the lower mounting cup in its correct installation orientation (dished downwards)**

Follow the manufacturers' installation procedures and apply the tightening torques specified by the manufacturer.
