Blue Print Bulletin

ADZ91107 and ADZ91113 Alternators

Date Issued: 01/11/01

We are aware of common vehicle faults associated with the charging system on Vauxhall applications using the Isuzu 1.5 and 1.7 diesel engines. The aim of this bulletin is to allow the correct diagnosis prior to replacing the alternator, and to assist in the prevention of further problems.

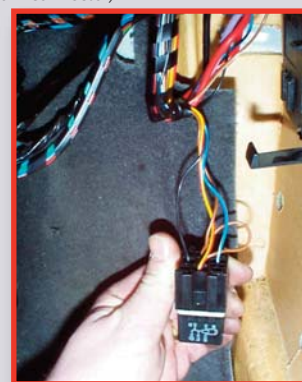
fig 5. - Relay removed

It is our experience that the *Charging Lamp Relay* is prone to failure. The relay controls the dashboard charging light operation and alternator excitation. It also gives a signal to the diesel system self-diagnostics and glow plug control unit for post-glow operation.

- ***We strongly recommend that the relay is changed as a matter of course when replacing the alternator, as it is possible for an internal alternator fault to damage the relay whilst in operation.***
