# VKJA 5756

## Technical Bulletin – December 2010

Technical Information: VKJA 5756 Replacement guidelines

This bulletin describes the replacement guidelines of a wheel side CVjoint on a Renault LAGUNA Grandtour (K56\_) 2.0 (K56C/H).

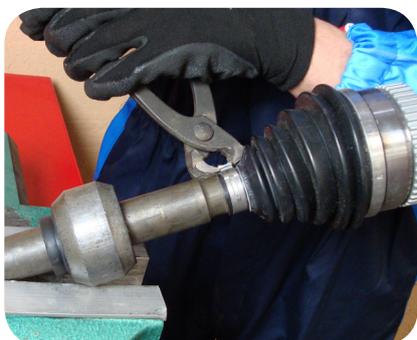
1. Remove the driveshaft in accordance with the vehicle manufactures' workshop manual.

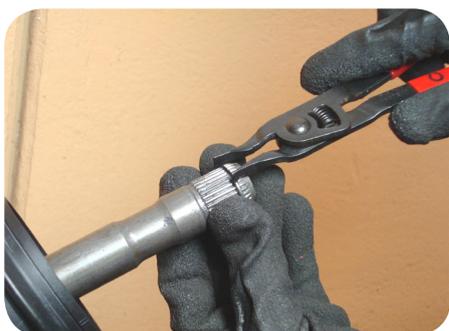
2. Place the driveshaft in a vice (with aluminum or protective jaws).

Remove both the inner and the outer clips.  
Cut the boot and remove it.

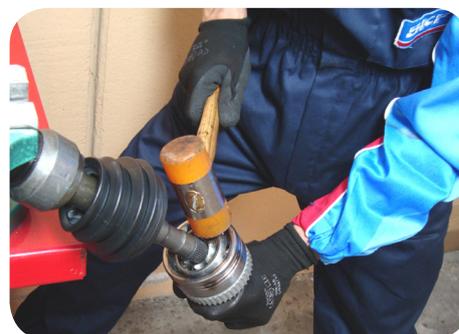
3. Hold the CV-Joint and pull it off the shaft by tapping with a hammer

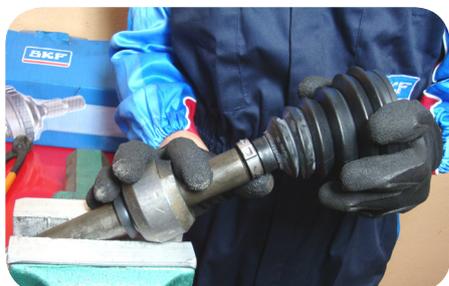
4. Expand and remove the circlip with circlip removal pliers.

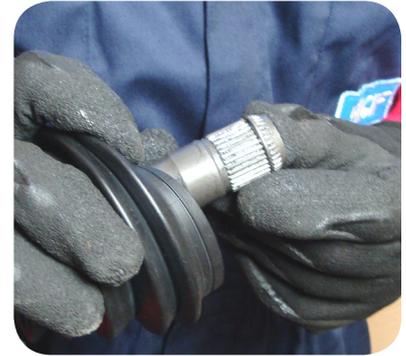
1. Put the short boot clamp on the shaft.  
Slide the boot on the shaft.

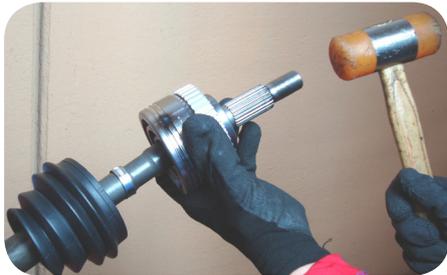
2. Fix the new circlip into the groove.  
Tip: To keep it into the groove use a hose clip (do not over tighten!)

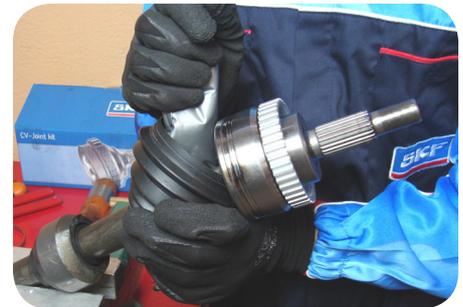
3. Press the new CV-joint onto the shaft.  
Tap with a rubber hammer until the circlip locks into its groove in the inner race of the CV-joint.  
Remove the hose clip.

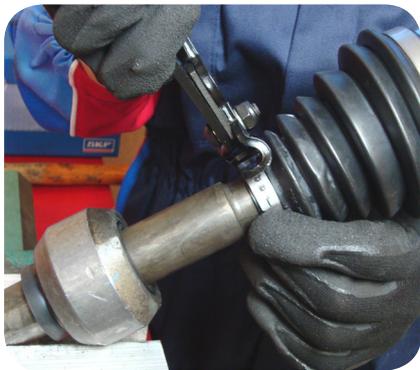
4. Slide the boot into position ready for mounting and fill with all of the supplied grease.

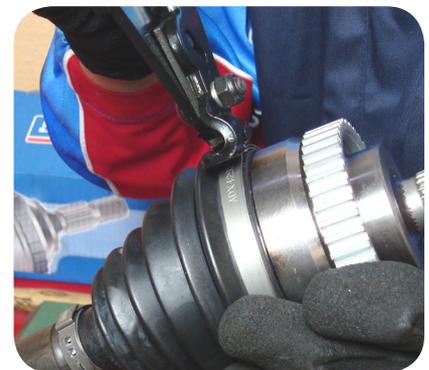
5. Fit the short clamp onto the CV-boot and tighten it with a suitable tool.  
Pull the boot onto the CV-joint.

6. Fit the long clamp and tighten it with the same tool.
