Tensioner/kit installation on PSA diesel engines

GATES REFERENCE:	T41139, T41140 & related kits.

MAKE:	CITROEN / FIAT / LANCIA / PEUGEOT / SUZUKI / TOYOTA.	
MODEL:	Various.	
MOTOR:	1.9D, 1.9HDI, 2.0HDI, 2.0JTD, 2.0TDI, 2.2 HDi, 2.2JTD.	
MOTOR CODE:	Various.

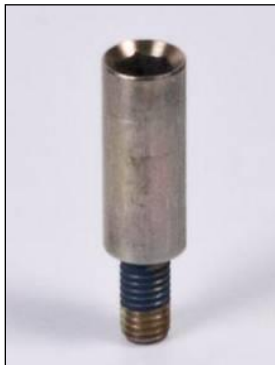
Fig. 1

We've found several cases where the tensioner pulley was not positioned correctly over the mounting stud (Fig. 1).

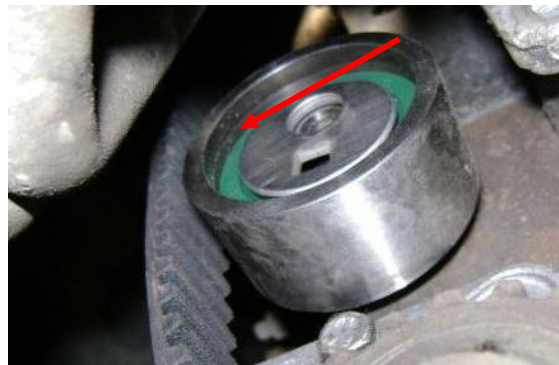
Fig. 2

If the inside of the tensioner front plate rests against the front edge of the mounting stud (Fig. 2 and 3), this results in the tensioner pulley not sitting straight over the stud even after the fixing bolt (Fig. 4) is installed with the correct torque. This will lead to belt misalignment, resulting in a premature failure.
