The correct parts that will help you carry out a professional front axle repair!

Bolt set for front axle repair kit 27876 Reference no. N 909 548 02 S1

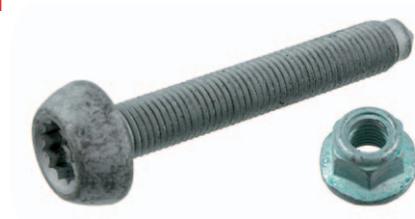
febi no. 27876

Fits
Golf 5, Eos, Caddy, Fox, Passat 5,
Tiguan, Touran, Fox, Polo 9N, Audi A3, Audi A4,
Audi A5, Audi TT, Altea, Cordoba, Ibiza, Leon,
Toledo, Fabia, Octavia, Roomster

When repairing the front axle, the shock absorber often has to be separated from the wheel bearing housing. To do this, you need to remove the fixing nuts & bolts. In many cases, the nuts & bolts have been over-torqued and can be seized or corroded. Therefore dismantling can take extra time. Re-using the old nuts & bolts would make it even more difficult to dismantle the unit in the future.

febi bilstein recommends to replace the original nuts & bolts with a new set each time to ensure a professional repair, using febi's approved OE quality parts.

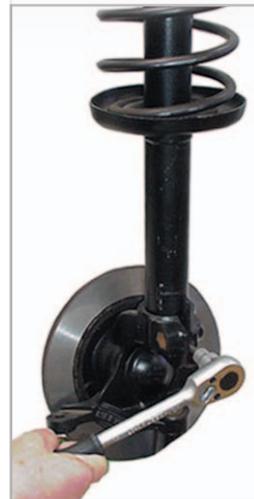
To help with removal, we recommend using KLANN tools KL-0101-1 and KL-0101-2.
