Service Info

Tensioner pulleys 531 0252 30 and 531 0525 30

Risk of mix-ups

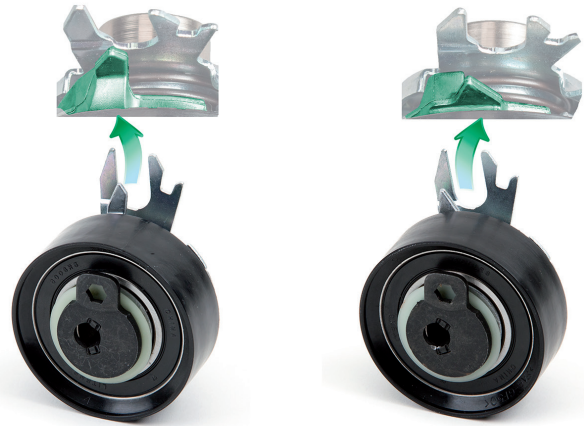
Only the indicator of the two tensioner pulleys and its arrangement are different (Fig. 1).

Fig. 1: Left - tensioner pulley 531 0252 30, right - tensioner pulley 531 0525 30

Before installation, it is extremely important to verify the part number. The similarity of the numbers increases the risk of mix-ups.

Although they look very much the same, they are technically very different. Tensioner pulley 531 0252 30 has a higher tensioning force and a larger working range than tensioner pulley 531 0525 30.

Use of the wrong tensioner pulley can cause the toothed belt to flutter and jump teeth. Engine damage may occur as a result.

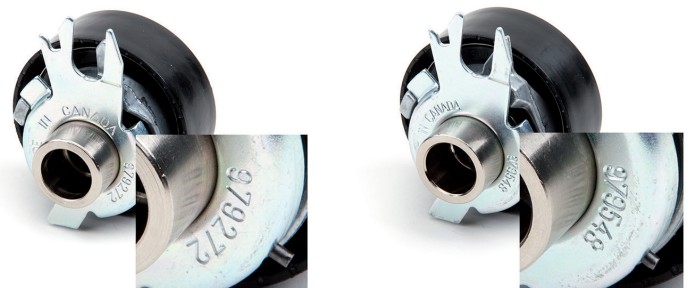
The number stamped on the back also helps to differentiate between them (Fig. 2):

article number	stamped number
531 0252 30	979272
531 0525 30	979548

Fig. 2: Left - tensioner pulley 531 0252 30, right - tensioner pulley 531 0525 30
