## Optimized tensioning pulley 531 0564 30

1.4i 16V (AFH)

**LuK AS Part No.:** 531 0564 30

**INA 0009**

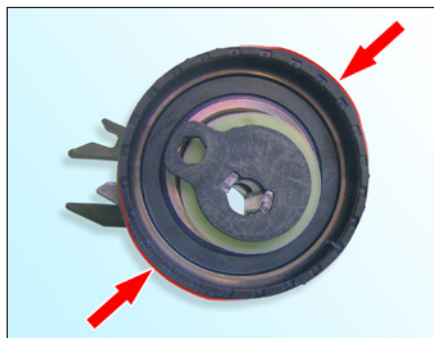
**Fig. 1:** 531 0564 30 (front view)

Tensioning pulley **531 0564 30** (sinus pulley) is a noise-optimized tensioning pulley, developed specially for the applications outlined above.

The red markings (**fig. 1** and **fig. 2**, arrows) highlight the features.

The unusually formed running surface is **not** a production fault!

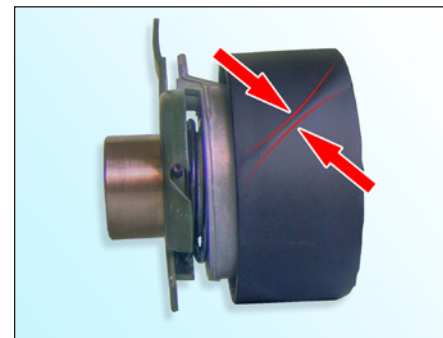
**Fig. 2:** 531 0564 30 (side view)

The running surface of the tensioning pulley has diagonal elevations (**fig. 2**).
