Visual differences of the tensioning pulley 531 0628 30

LuK AS Part No.: 531 0628 30

OE-No.: 03G 109 243

Issued 11.2007
INA 0012

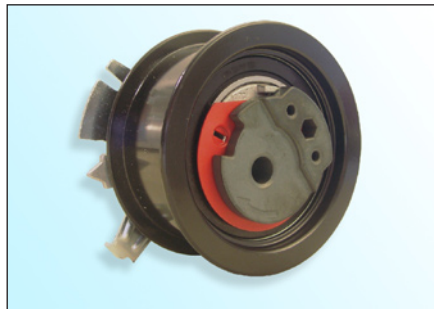
Fig. 1: 531 0628 30 (old version)

Visual characteristics:

- Cam made from sinter metal
- Surface coat E-Coat (black)
- black bearing seal

The „old version“ of the tensioning pulley is **not** made completely redundant and can still be used and assembled in accordance with the instructions provided by the manufacturer!

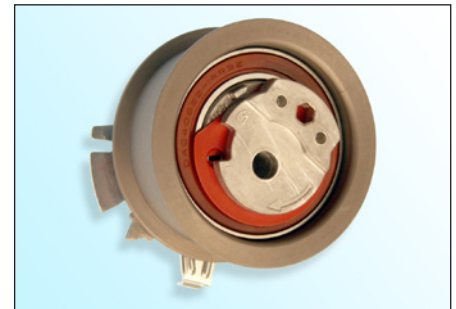
Fig. 2: 531 0628 30 (new version)

Visual characteristics:

- Cam made from cast aluminium
- Surface coat Zinc phosphorous (light brown)
- brown or black bearing seal

When assembling the „new version“, ensure that the surface coat of the tensioning pulley is **not** damaged!
