Blue Print Bulletin

ADC48226 Front Wheel Bearing

Subject – Application Guide

Vehicle - Mitsubishi Shogun & Pajero models 2000>

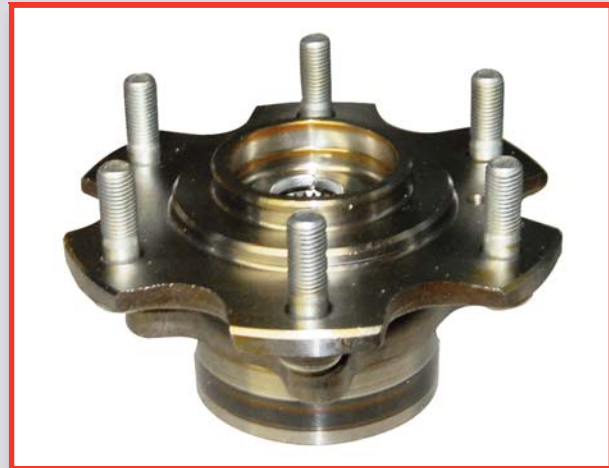
1. Fit the washer on the Hub assembly, with the washer's chamfered face **towards** the castle nut.

Correct position of washer

See Image (on right).

2. Tighten the castle nut to $200 \pm 10 \text{Nm}$.
