Different tensioning pulleys depending on design of crankshaft drive sprocket (round or oval)

Various Ford/ PSA/ Volvo 1.6L diesel, article nos. CT1162K2/ K3/ K4 and WP2/ WP3/ WP4

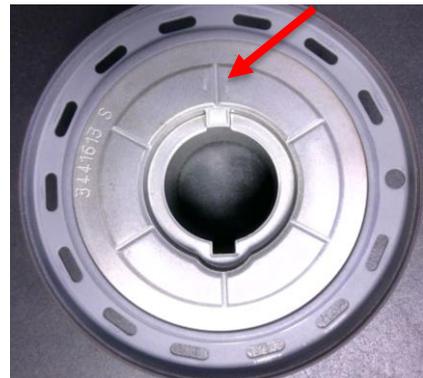
Fig. 2

Different tensioning pulleys have different tension spring rates. The rate must be suitable for the crankshaft drive sprocket installed at the factory. In recent years, the manufacturer has brought in an optimized timing drive with an "oval" sprocket. The two designs of sprocket look the same at first glance. To see which it is, take it off and check whether there is a recess drilled in the back (**Figs. 2 and 3**).

Round drive sprocket

For the crankshaft sprocket with no recess (round design, **Fig. 2**), always use the timing belt kit CT1162K2/ WP2 with tensioning pulley V56664. If the sprocket has a recess (oval design, **Fig. 3**), you need **either** kit CT1162K3/ WP3 with tensioning pulley V56675 **or** kit CT1162K4/ WP4 with tensioning pulley V56676 (if both kits are listed for the vehicle, it is the year of manufacture which is the decisive point; to be sure, check the part number on the back of the tensioning pulley).

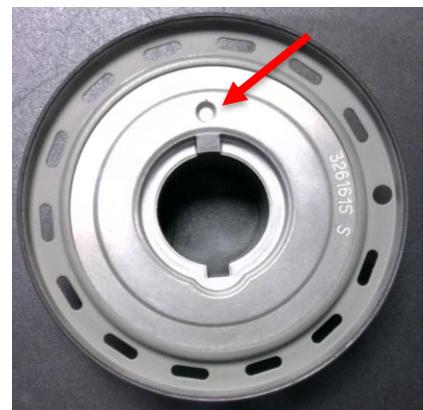
Fig. 3

Oval drive sprocket
