Conductor Plate Kit for automatic transmissions

febi no. 39942

Fits all Chrysler 5-gear automatic transmissions.

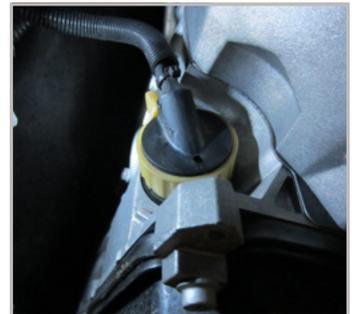
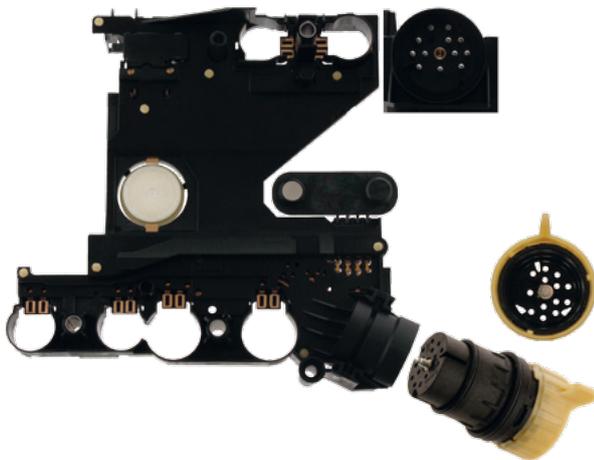
febi no. 39942

The sensors of the conductor plate stick together due to deposits in the automatic transmission fluid. This results in gear change malfunctions in the transmission.

Always replace the plug at the same time as replacing the conductor plate. Otherwise leaks may occur at the outlet from the conductor plate. As a result the oil perforates the seal and can therefore get into the automatic transmission control unit via the wiring loom and lead to damage in the control unit.

For this reason, febi bilstein supplies the complete kit febi 39942 which includes both the conductor plate febi 39482 and also the plug for automatic transmissions febi 36332. This combination enables a professional repair and avoids potential complaints. That saves time and money for both workshop and customer!
